An Analysis of Electric Power Faults in Mubi Undertaking Station, Adamawa State, Nigeria.

D.A. Shalangwa¹, D.Y. Shinggu², and T. Jonathan³

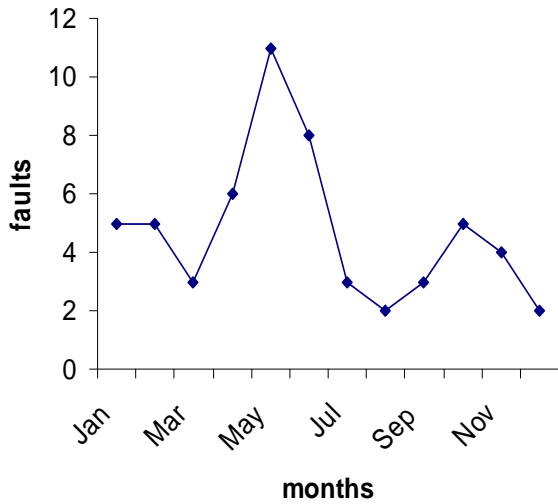
Figure 1: Monthly Breakdown of Faults in Domboa Feeder.

The monthly breakdown of faults monitored from January – December 2006 is analyzed in Figure 1 and Figure 2. These two graphs show that the month of May had the highest number of faults followed by June 2006. In Figure 1, the lowest level of faults were recorded in the month of December followed by November. Figure 2, the lowest number of faults were recorded in the month of August. These monthly faults in the two feeders were combined in Figure 3 and shows that the month May had highest number of faults in the year followed by June. This may be attributed to thunder storm, rain storms, and strong wing activities during the early rainy season of the year in the Northeastern region of Nigeria.

The lowest level of faults were recorded in the month of December followed by November when the no more thunder storms, rain storms, and strong winds are prevalent.

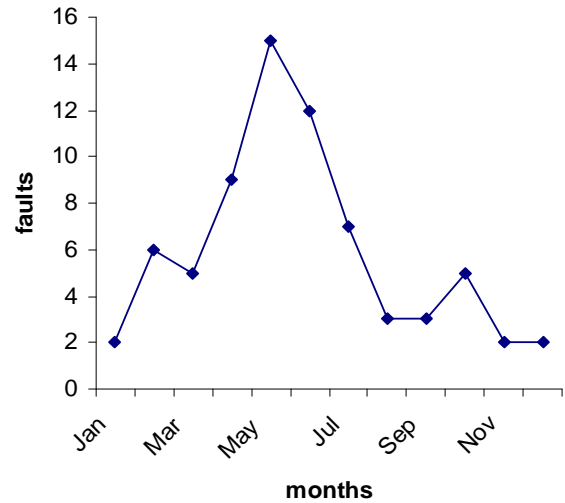
Figure 2: Monthly Breakdown of Faults in Gombe Feeder.

Table 2 indicates that faults appeared to occurs more frequently in Gombe feeder than Damboa which is about 55.5%. The reason for this may be related to the length that the Gombe feeder covers which is a wider area and may be subjected to many outdoors variables.

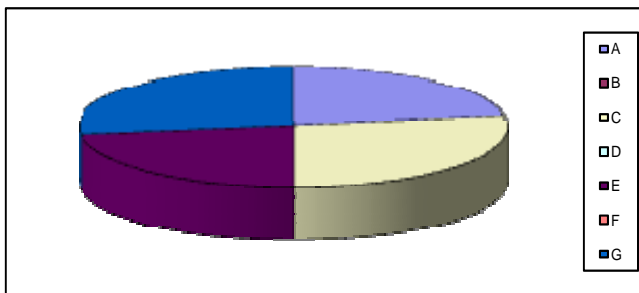
Figure 4: Fault Distribution Pie Chart.

Figure 4 describes the frequency of the faults (faults angle) occurred in the two feeders, single phase to Earth faults and two phase faults occurred more frequently than the single phase to Earth faults through a resistor and two phase to earth faults. Open circuit faults, three phase faults and three phases to earth faults did not completely occurred throughout the year.

1. There should be proper vegetation management to reduce incidents of Earth faults,
2. All defective components should be replaced before the rainy season,
3. Animal guards should be provided on poles and towers,
4. Power Holding Company should adapt to underground transmission line connections, and
5. Power Holding Company should find a means of preventing birds and other animals from coming into contact with the power lines.
