Geophysical Investigation of Pavement Failure in a Basement Complex Terrain of Southwestern Nigeria.

O.J. Akintorinwa, Ph.D.^{1*}; J.S. Ojo, Ph.D.¹; and M.O. Olorunfemi, Ph.D.²

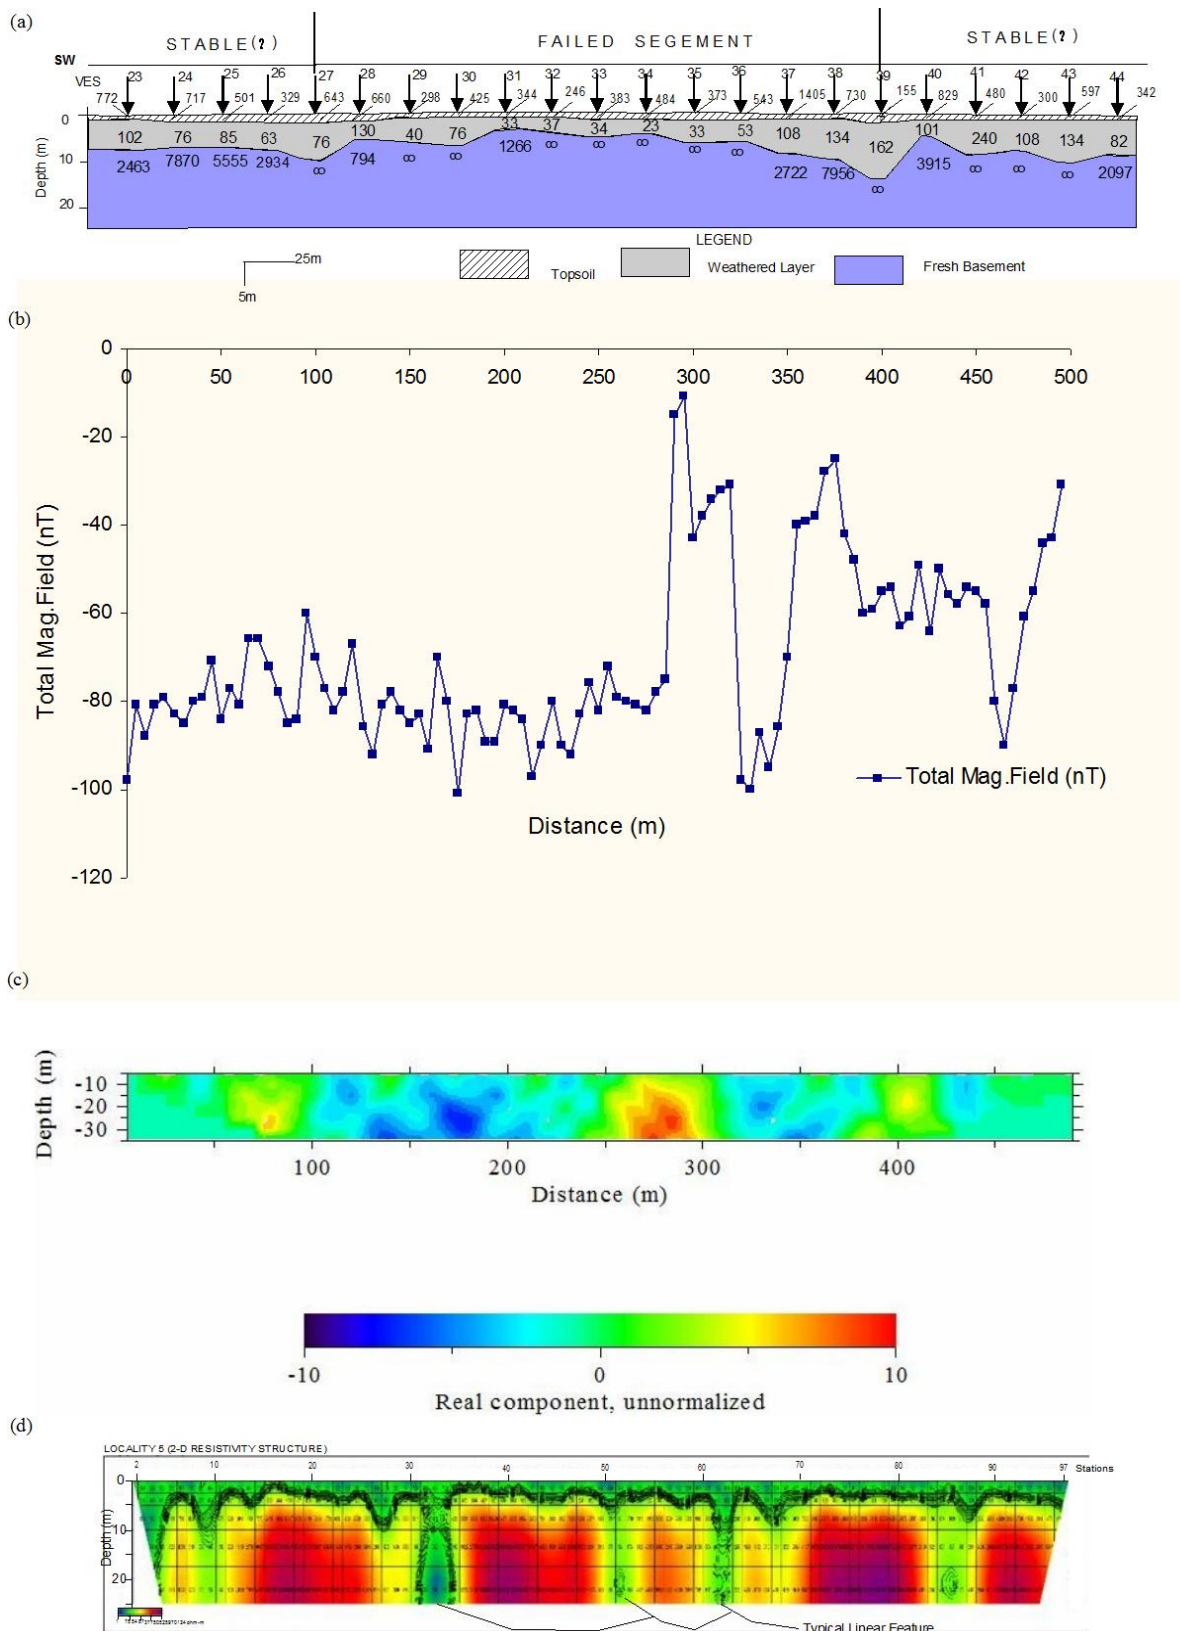
Figure 8: (a) Goelectric Section, (b) Magnetic Profile, (c) 2-D VLF Inversion Model and (d) 2-D Dipole-Dipole Resistivity Structure at Locality 1.

At failed locality 1 (Figure 8a), both the topsoil and the subsoil (weathered layer) in the upper 0-8 m are clayey within the failed and the presently classified stable segments at the flanks with resistivity values generally less than 100 Ω -m (Table 3). The basement relief is uneven (Figure 8a and Figure 8d). Both the magnetic profile (Figure 8b) and the 2-D resistivity structures (Figure 8d) identify suspected linear features within the failed segment at distances 165, 255, 275m and 310 m and within the currently classified stable segment at distances 45 and 425 m.

Some of these linear features display fairly high conductivity on the VLF-EM 2-D model (Figure 8c). The identified linear features have significant depth extent (>5 m) which may indicate geological features such as fractures and faults. Road pavement failure at this locality may have been precipitated by a combination of an incompetent clayey subsoil and network of near-surface and subsurface linear features suspected to be lithological contact or fault/fracture zones.

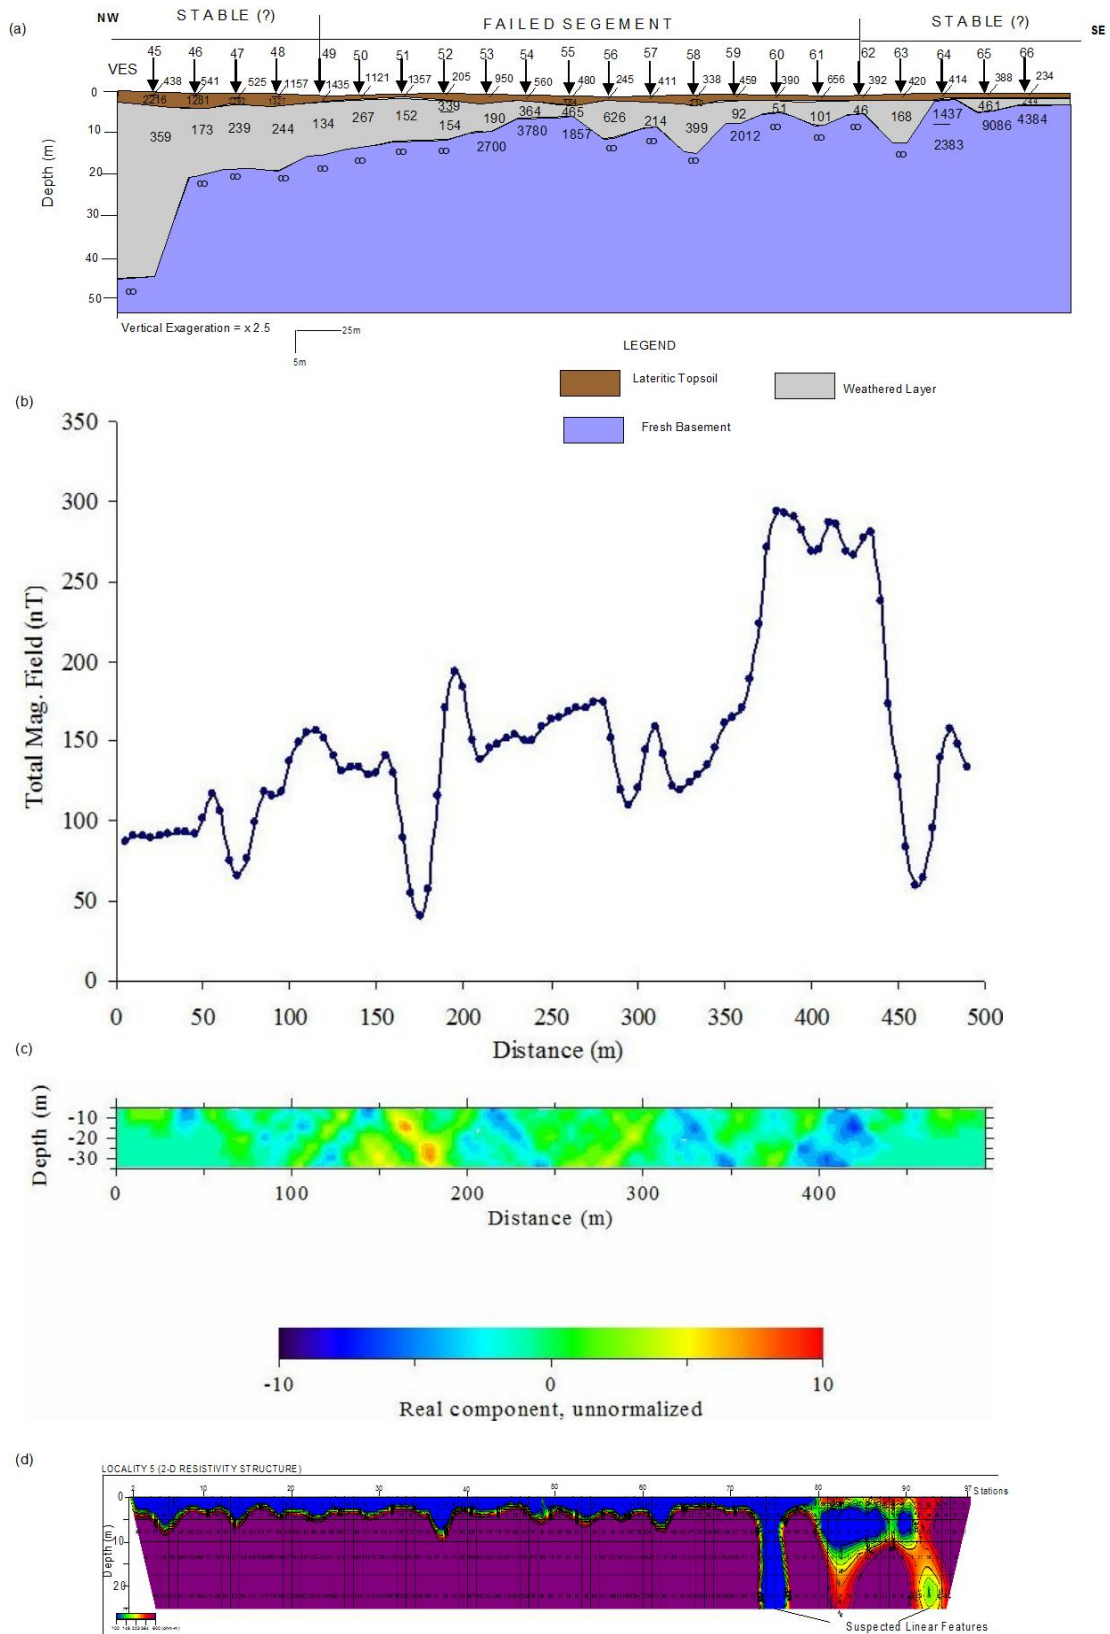
Figure 9: (a) Geoelectric Section, (b) Magnetic Profile, (c) 2-D VLF Inversion Model and (d) 2-D Dipole-Dipole Resistivity Structure at Locality 5.

Locality 5 (Figure 9a) has sandy clay/clayey sand and laterite in the upper 0.8-2.1 m with resistivity values generally greater than 200 Ω -m (Table 4).

The underlying weathered layer is predominantly sandy clay/clayey sand within the failed and the presently classified stable segments at the flanks with resistivity values generally greater than 200 Ω -m (Figure 9a). The basement relief is uneven (Figure 9a and Figure 9d). The magnetic profile (Figure 9b) and the 2-D resistivity structure (Figure 9d) identify suspected linear features within the failed segment at 185 m, 310 m and 370 m and the presently classified stable segment at 70 m and 490 m.

Some of these linear features show fairly high conductivity on the VLF-EM 2-D model (Figure 9c). All the identified linear features have significant depth extent (> 7 m) and this may indicate geological features, such as fractures, faults and lithological contacts. Failure at the locality 5 may have been due to network of near-surface and subsurface linear features suspected to be lithological contact, fault/fracture zone.

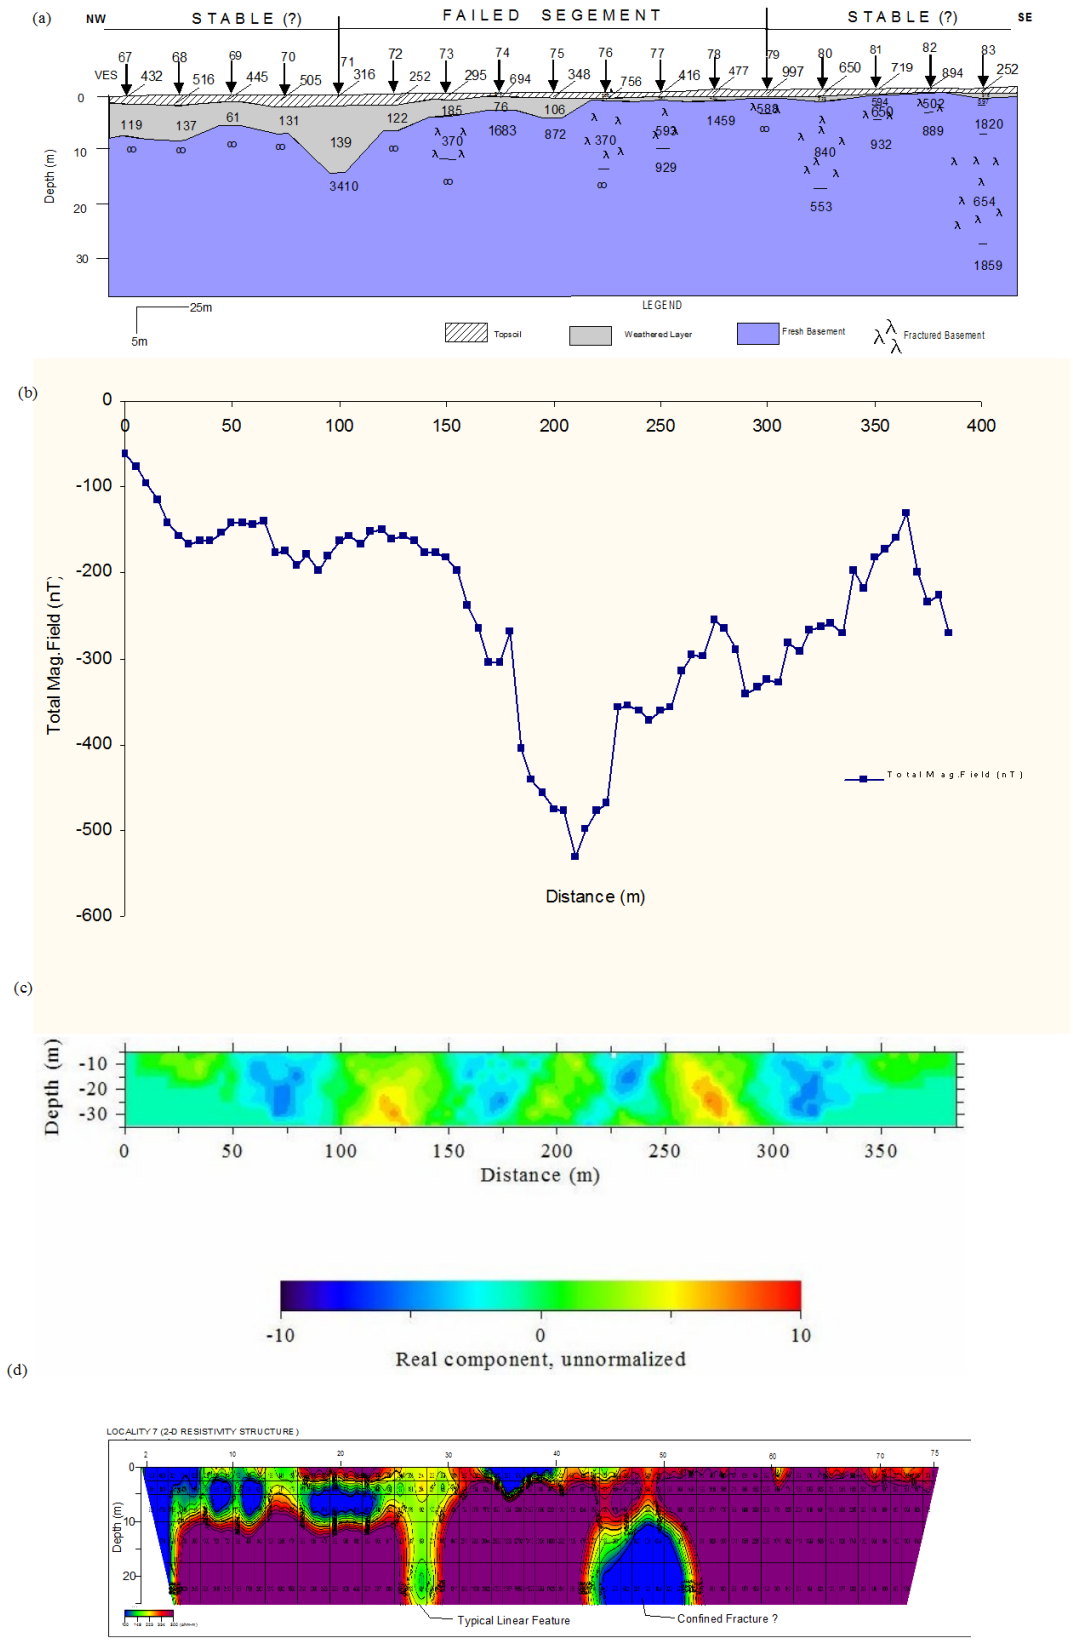
Figure 10: (a) Geoelectric Section, (b) Magnetic Profile, (c) 2-D VLF Inversion Model and (d) 2-D Dipole-Dipole Resistivity Structure at Locality 7.

Both the topsoil and the weathered layer in the upper 0-8 m at the northwestern flank of locality 7 is composed of clay, sandy clay and clayey sand beneath the failed and the currently classified stable segments at the flanks with resistivity values generally less than 200 Ω -m (Figure 10a). The southeastern flank has a relatively thin overburden (maximum 1.6 m) and it is composed of clayey sand and laterite with resistivity values generally greater than 200 Ω -m (Table 5).

The basement bedrock interface is uneven and dipping toward the northwest (Figure 10a and Figure 10d). A linear feature suspected to be a fault or lithological contact is located at distance of 140 m on the 2-D resistivity structure (Figure 10d). This feature was also delineated by the VLF-EM 2-D model (Figure 10c) and magnetic anomaly (Figure 10b).

A suspected confined basement fracture is located between distance of 215m and 260m on the 2-D resistivity structure (Figure 10d), which falls within an intensively fractured basement bedrock zone delineated between distance of 225m and 400m on the geoelectric section (Figure 10a). These identified linear features fall within the magnetic anomaly located between distance of 150m and 360m on the magnetic profile (Fig. 10b). All the identified linear features have significant depth extent and falls within the failed and the presently classified stable segments.

Failure at locality 7 may have been precipitated by incompetent clayey subsoil on the northwestern flank and network of near-surface and sub surface linear features suspected to be lithological contact or fault/fracture zones on the southeastern flanks.

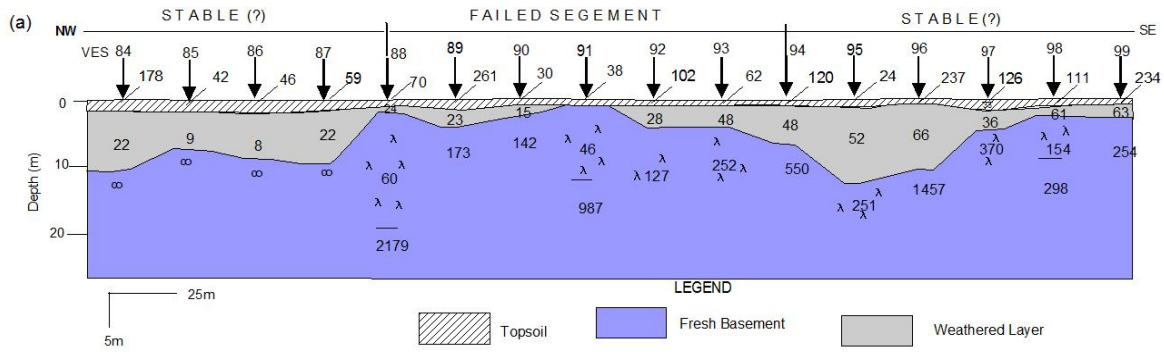
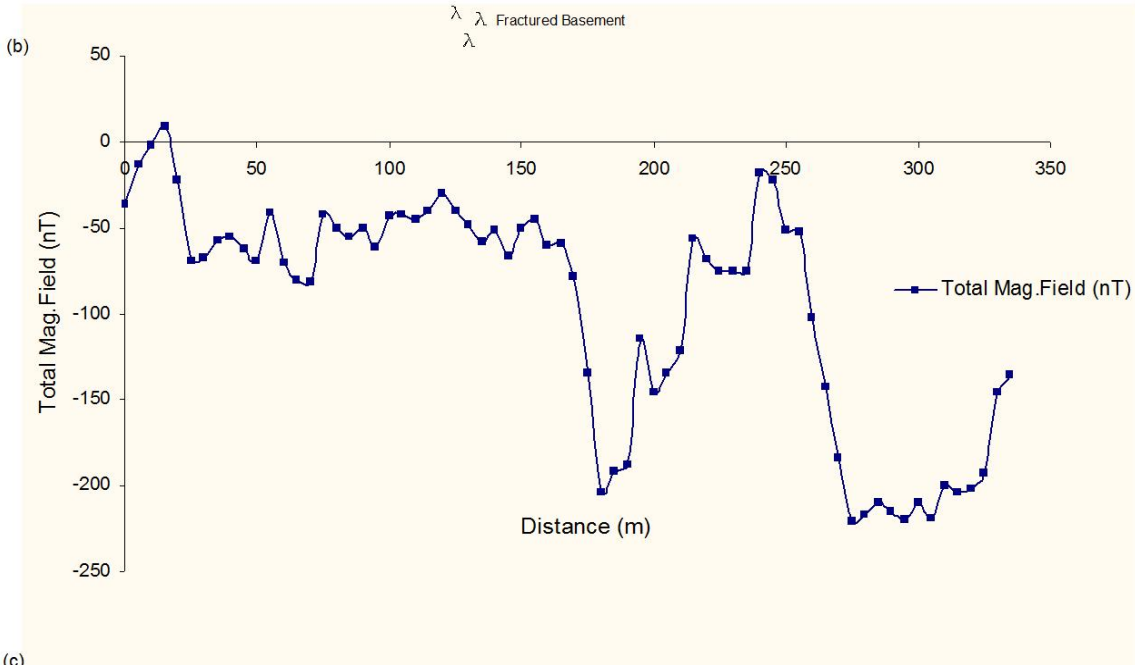
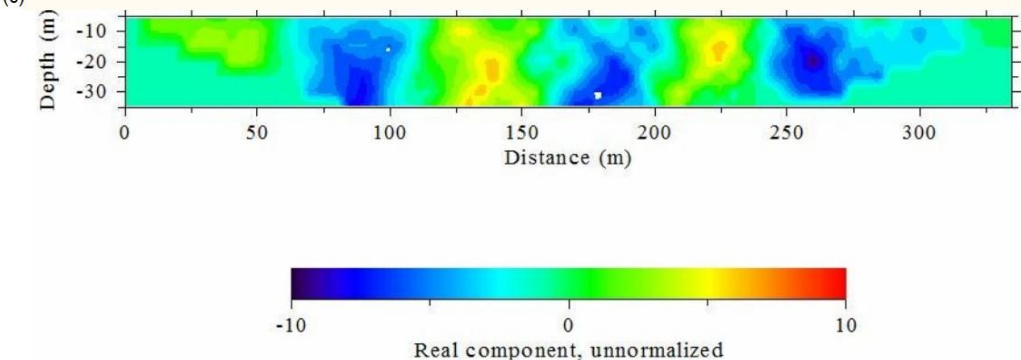
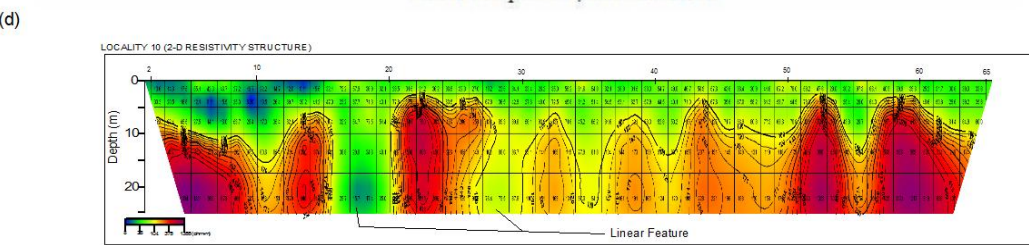
Figure 11: (a) Geoelectric Section, (b) Magnetic Profile, (c) 2-D VLF Inversion Model and (d) 2-D Dipole-Dipole Resistivity Structure at Locality 10.

At locality 10 (Fig. 11a), the topsoil and the weathered layer within the failed and the currently classified stable segment flanks are composed of clay which is up to 10 m thick. The resistivity values are generally less than 100 Ω -m (Table 6).

The basement bedrock topography is uneven (Figure 11a and Figure 11d). The 2-D resistivity structure (Figure 11d) identify suspected linear features within the failed segment at distances of 145 m and 175 m and within the "stable" segment at distances 90 m and 275 m. Some of these linear features show fairly high conductivity on the VLF-EM 2-D inversion model (Figure 11c).

The identified linear features have significant depth extent (> 12 m) and may indicate geological features such as fractures/faults and lithological contacts. Failure at this locality may have been precipitated by a combination of an incompetent clayey subsoil and network of near-surface and subsurface linear features suspected to be faults/ fracture zones.
