Application of Geophysical Imaging in Investigation of Structural Failure of Buildings: Case Study of Three Building Sites in Zaria Area, Northwestern Nigeria.

G.N. Egwuonwu, Ph.D.

Department of Science Technology, Nigeria Institute of Leather and Science Technology, Zaria, Nigeria.

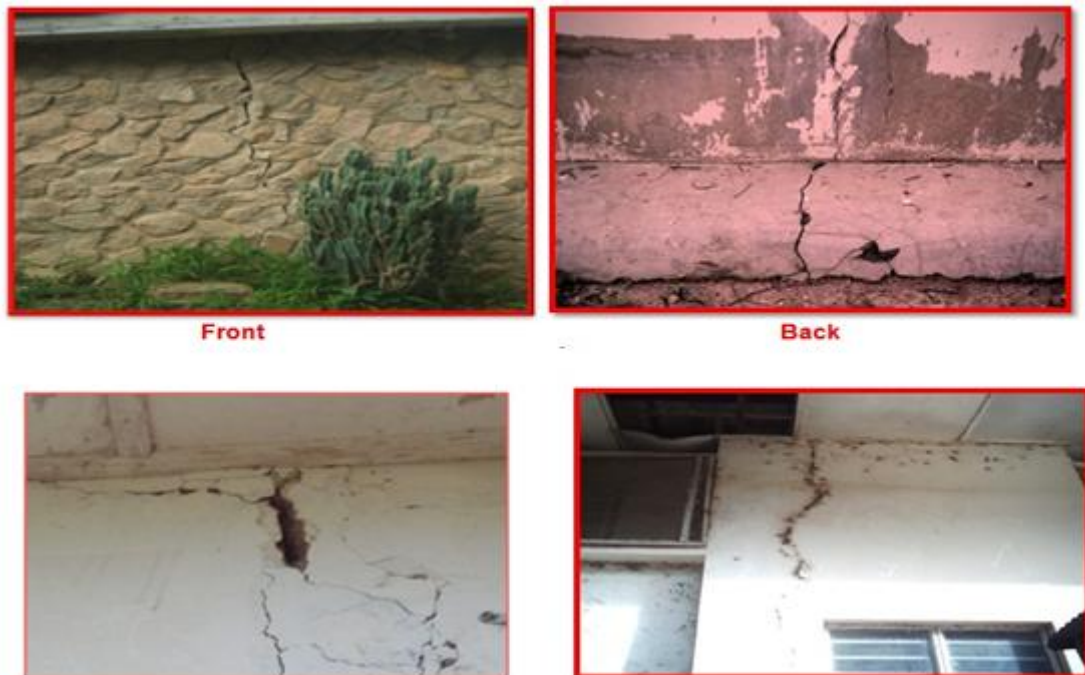
Site one's building has been under maintenance with masonry patches which have not provided a permanent solution to the problem. Although some of the cracks observed were not originated from the foundation but from the roof owing to poor masonry work. The most prominent crack is a major vertical cracks which divides the building at its centre in NE-SW direction (Figure 1).

Figure 1: Some Views of Cracks on Site 1 Building.

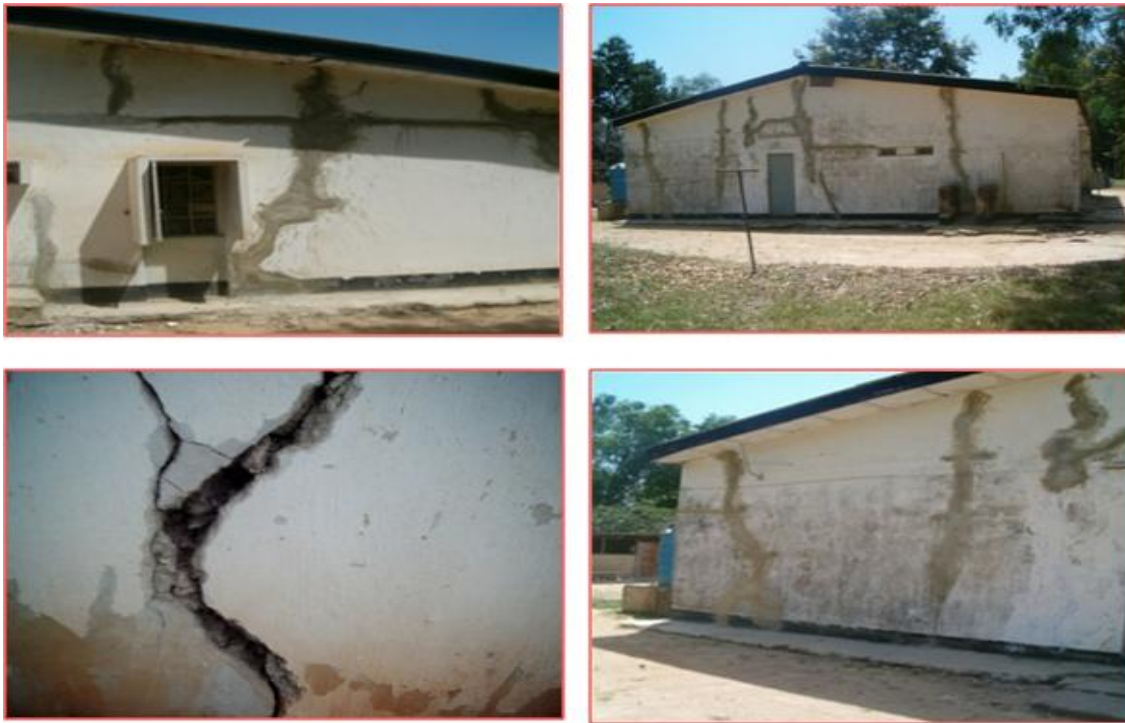
Site 2 of the study area is a two bedroom bungalow. For over one decade, the building has been undergoing repairs annually as reported by the occupant of the building. The most prominent crack is a vertical one which divides the building almost into two trending east-west direction and originating from the foundation where its occurrence is widest (Figure 2). Preliminary survey of the site shows that the building's site is principally characterized by clayey top soil.

Figure 2: View of Some Cracks on Site 2 Building.

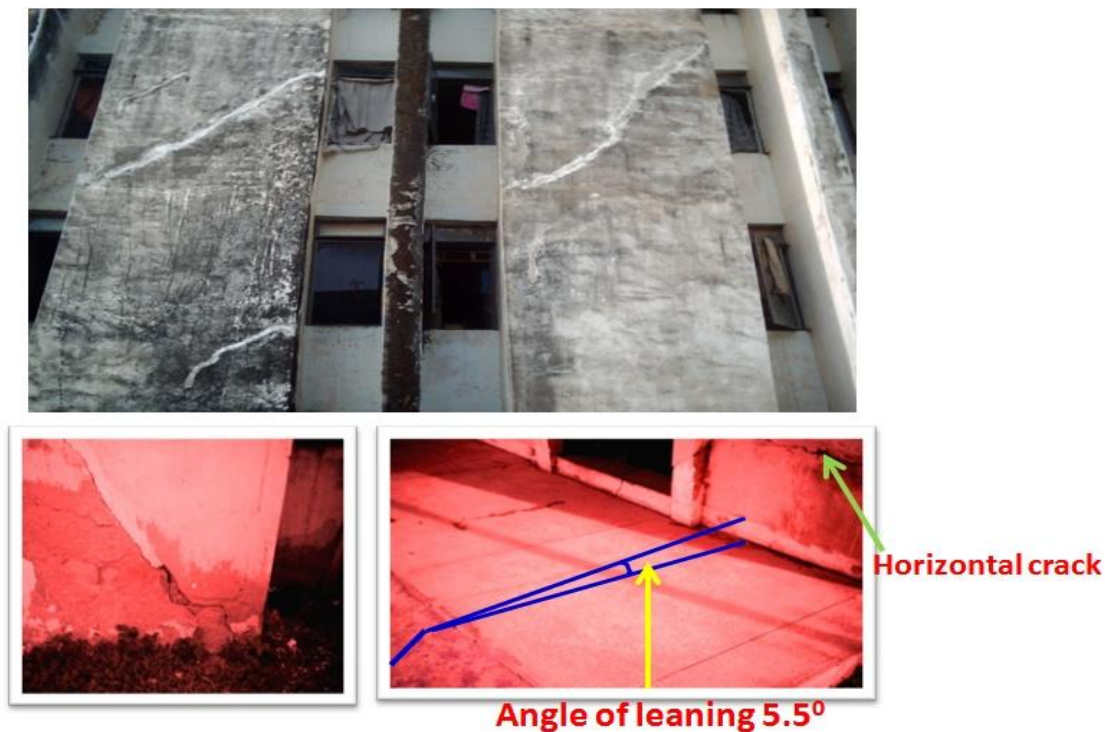
Site 3 of the study area is a university students' hostel block. It is a three storey building consisting of about 48 rooms. Outstandingly, the building settlement was observed to be leaning in West-East direction of the site at the angle of about 5.50° and its deepest settlement depth is about 0.675 m (Figure 3). Presently, the building is considered unsafe and dangerous for habitation hence evacuated. Geophysical investigation is therefore required necessary in order to map the subsurface structures underlying the buildings having structural failure.

Figure 3: Danger of Diagonal Cracks, Horizontal Cracks, and Angle of Leaning (Site 3).

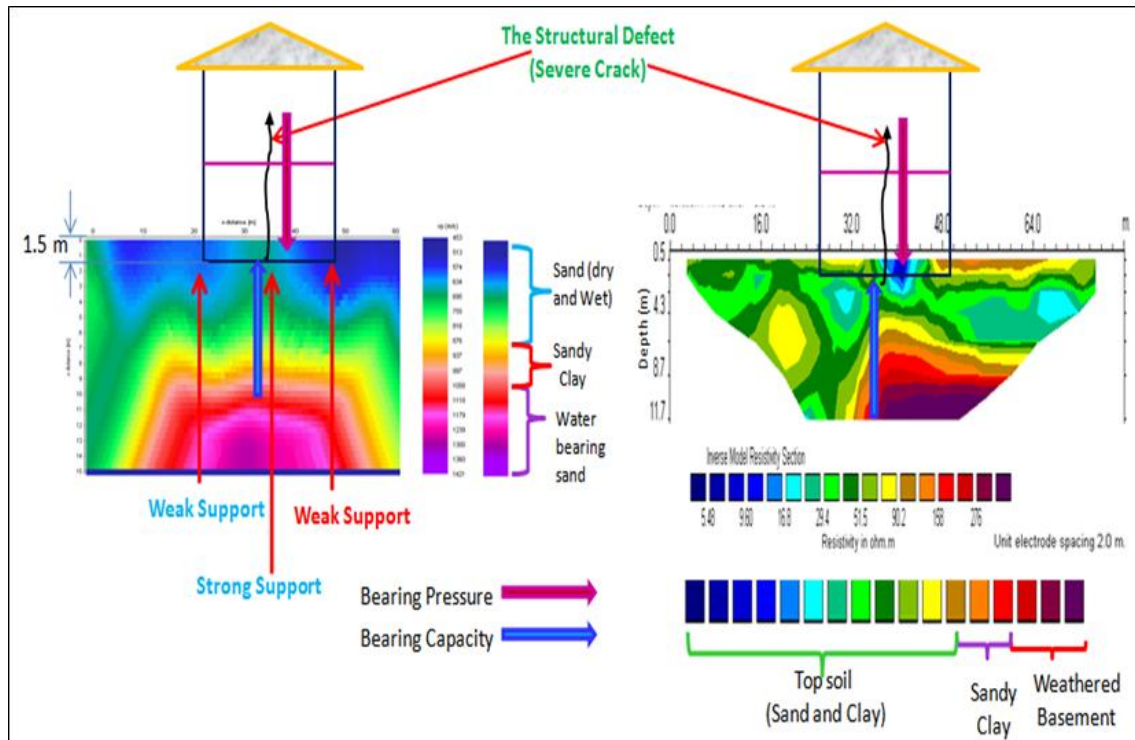
The building selected from site 1 is located very close to one of the minor valleys in the area. The zone directly beneath the major crack at the site has relatively higher p-wave velocity than its lateral surrounding at the front side of the building. This suggests that there are consolidation or compaction contrasts underlying the building owing to variation in compressibility. The compressibility contrast within the sandy clayey zone is as a result of the high consistency of the soils which results to compaction and density contrasts. The building therefore exerts its bearing pressure since its construction was completed. The pressure being exerted by the building on the subsurface owing to its gross weight invariably results in a progressive consolidation settlement of the building. During this consolidation which usually follows after the **immediate settlement**, one side gradually gets consolidated faster than the other thereby serving as a stronger support than its flanks.

Figure 4: Seismic Refraction and Electrical Resistivity Tomograms and, Structural Failure Mechanism at Site 1.

This therefore suggests that consolidation or compression contrasts at the two sides might have contributed to the occurrence of the major and severe vertical cracks NW-SE on the building (Figure 4). Other probable reason for the structural defects on the site 1 building is the problem of swell and shrinkages of clayey soils. Seasonal variation in the level of saturation of clayey soils is expected to have given rise to the seasonal swelling and shrinkages of the building's subsurface.

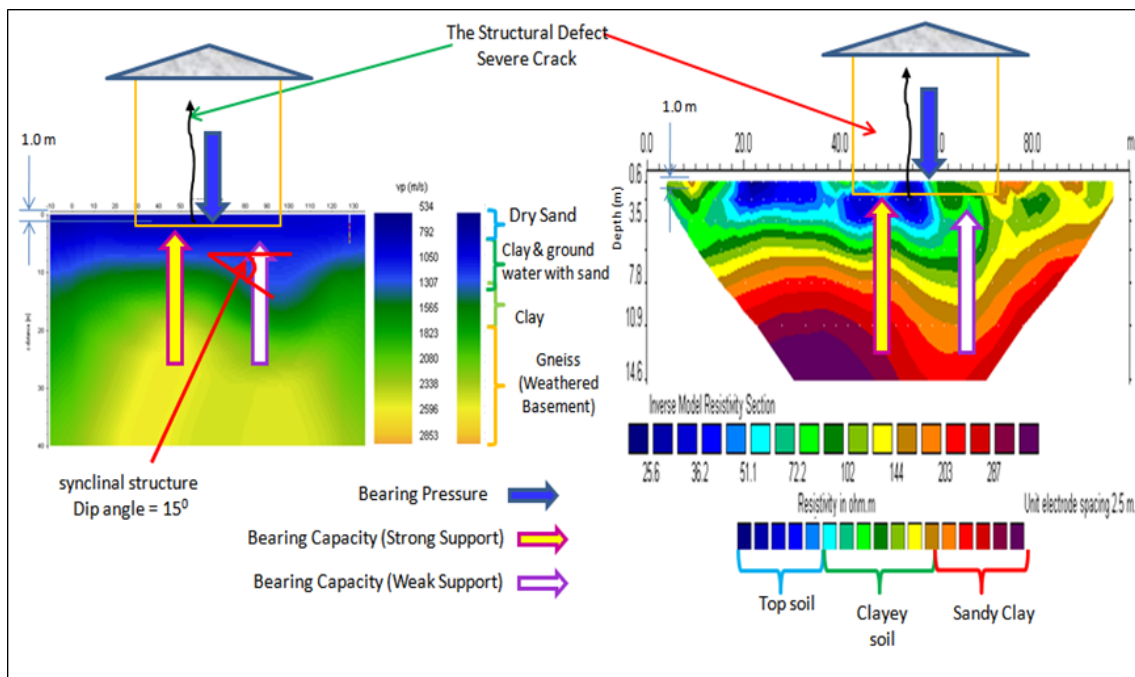
Figure 5: Seismic Refraction and Electrical Resistivity Tomograms and, Structural Failure Mechanism at Site 2.

Results also show that the site 2 building is characterized by gentle EW dipping, prominent synclinal structures, fractured zones and clayey soil at shallow depths. While the overburden

materials fill the fractured zones, their columns undergo ground movement by subsidence thereby could amount to uneven settlement at the foundation depths of the building. In other words, uneven stress distribution occurs at the foundation depths subsurface that is, one side of the structure to having a stronger support than the other side of it (Figure 5).

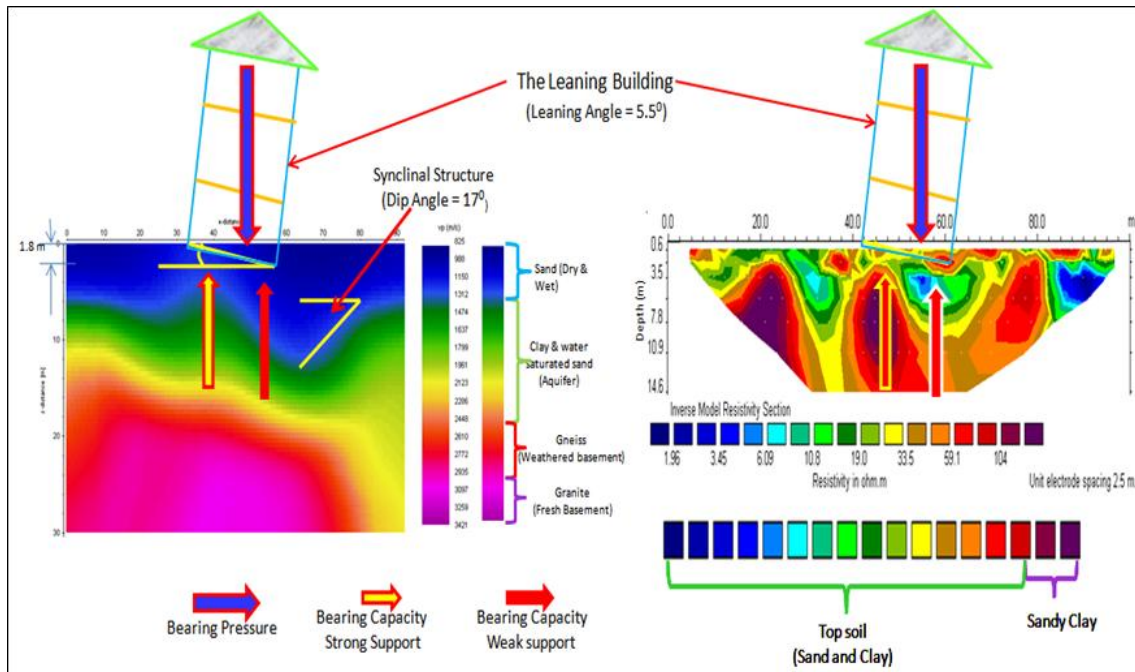
Figure 6: Seismic Refraction and Electrical Resistivity Tomograms and, Structural Failure Mechanism at Site 3.

The site 3 tomograms also show significantly synclinal geologic structure at shallow depths and a gentle dipping layering. The dipping and the synclinal structure shown by the pseudosections of these profiles suggest that they could be the major basis for the structural failure of the site 3 building.

The weight of the superstructure which is three storey students' hostel building was initially supported by a seemingly stable subsurface at the end of its construction four decades ago must have undergone also differential settlement. Hence tomograms show that the front side of the building rests on a weaker support than the rear side of it (Figure 6). Table 4 shows the deductions from seismic refraction tomography and electrical resistivity imaging.
