Time-Lapsed Geophysical Investigation of the Mokuro Earth Dam Embankment, Southwestern Nigeria, for Anomalous Seepages.

Akinola B. Eluwole, M.Sc. and Martins O. Olorunfemi, Ph.D.

Department of Geology, Obafemi Awolowo University, Ile-Ife, Nigeria.

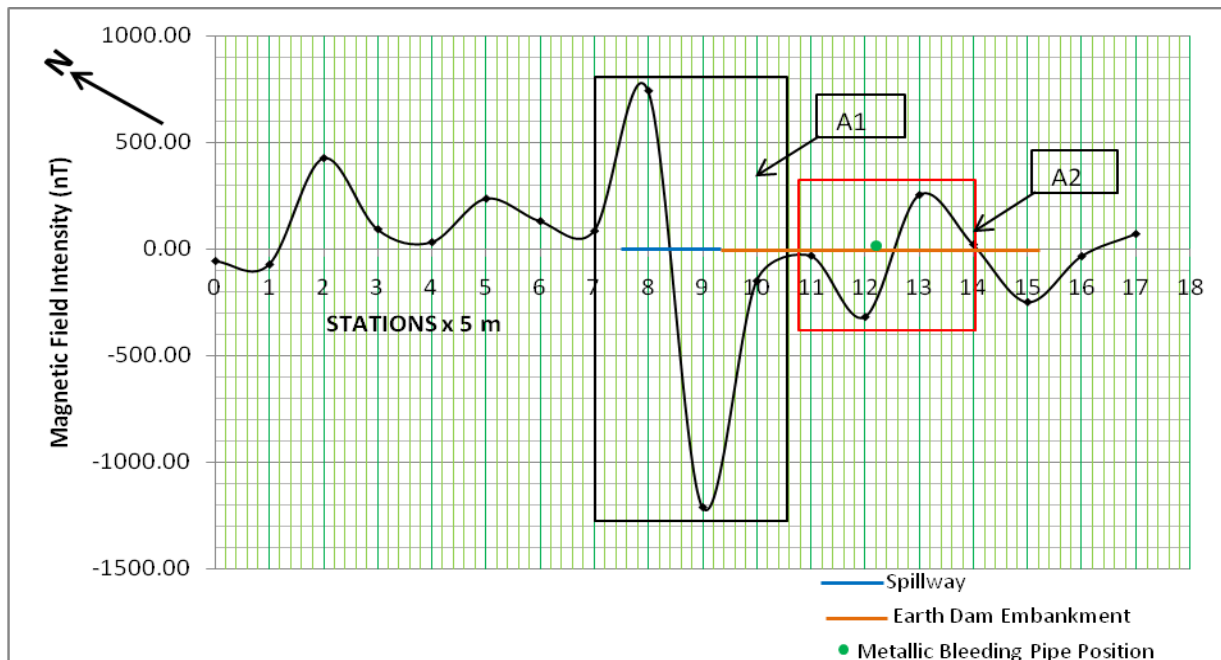
Figure 4: Magnetic Profile along the Dam Embankment.

Two significant magnetic anomalies A1 and A2 can be identified on the magnetic profile along the dam embankment (Figure 4). The first anomaly (A1) occurs between station 7 (35 m) and station 9 (45m) (Figure 4). The second anomaly (A2) occurs between station 11 (55 m) and station 14 (70 m) (Figure 4). Magnetic anomaly A1 (Figure 4) has relatively high peak positive (795 nT) and peak negative (-1220 nT) amplitudes. As shown in Figure 4, A1 is located on the spillway. The spillway is a steel rod reinforced concrete structure which constitutes a horizontal slab

supported by underlying vertical beams. It is suspected that the iron mesh within the spillway concrete structure may have been responsible for the magnetic anomaly A1. Magnetic anomaly A2 (Figure 4) has a moderate peak positive (254 nT) and peak negative (-318 nT) amplitudes. Its amplitudes, compared to that of anomaly A1 could suggest a relatively deep causative body or a smaller dimension magnetic body located at shallow depth. However the metallic bleeding pipe located at a depth of about 2.5 m within the dam embankment at station 12.2 (61 m) may have been responsible for this anomaly. Using Parasnis, 1986 semi-quantitative interpretation technique, the depths to the top of the magnetic bodies causing anomalies A1 and A2 were

estimated to be 2.9 and 2.5 m respectively. The 2.9 m depth estimated for anomaly A1 suggests that the magnetic anomaly A1 could be a cumulative response from the mesh of iron rods within the horizontal concrete slab and that of the iron rods within the vertical beams.

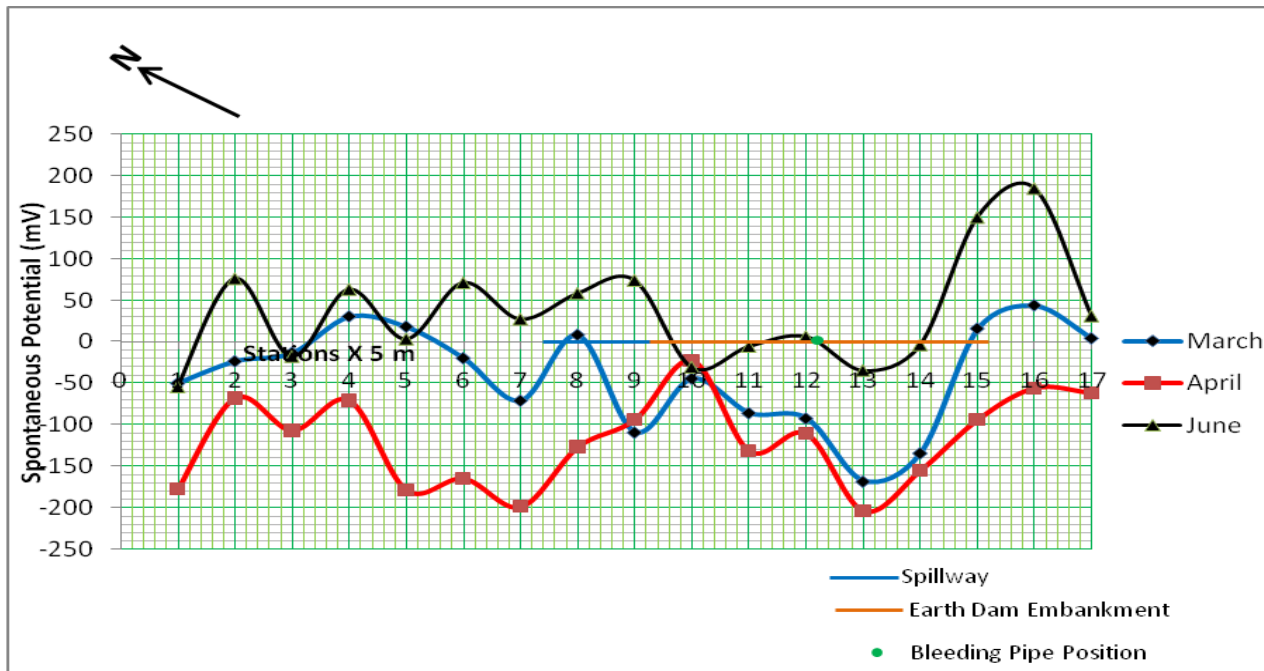
Figure 5: Multiple Plot of all the SP Profiles.

Figure 5 shows a multiple plot of the SP profiles obtained during the three phases of measurement. The profiles display similarities in shape/pattern or anomaly form. SP troughs which are indicative of zones along the dam embankment with high streaming potentials and/or diagnostic of highly conductive bodies were identified across the profiles at stations 3 (15 m); 5 (25 m); 7 (35 m); 9 (45 m); 11 (55 m); and 13 (65 m).

The troughs at stations 7 (35 m); 11 (55 m) and 13 (65 m) were consistently recorded during the three phases of measurement indicating prominent SP sources. The troughs at station 3 (15 m); 5 (25 m) and 9 (45 m) were observed only twice; in April and June for stations 3 and 5 which may be due to fluid streaming and March/April for station 9. SP negative troughs with peaks at stations 11 and 13 fall on the earth dam embankment.

The negative peak at station 11 (55 m) may be due to the bleeding pipe located beneath station 12.2 while the second negative peak at station 13 (65 m) may be due to seepage path. It is suspected that the SP anomalies from these two sources may have been superimposed due to their closeness resulting in slight shift of their troughs. The low amplitude peaks at stations 3 (15 m) and 5 (25 m) outside the dam embankment may be indicative of minor linear features within the subsoil acting as water conduit.

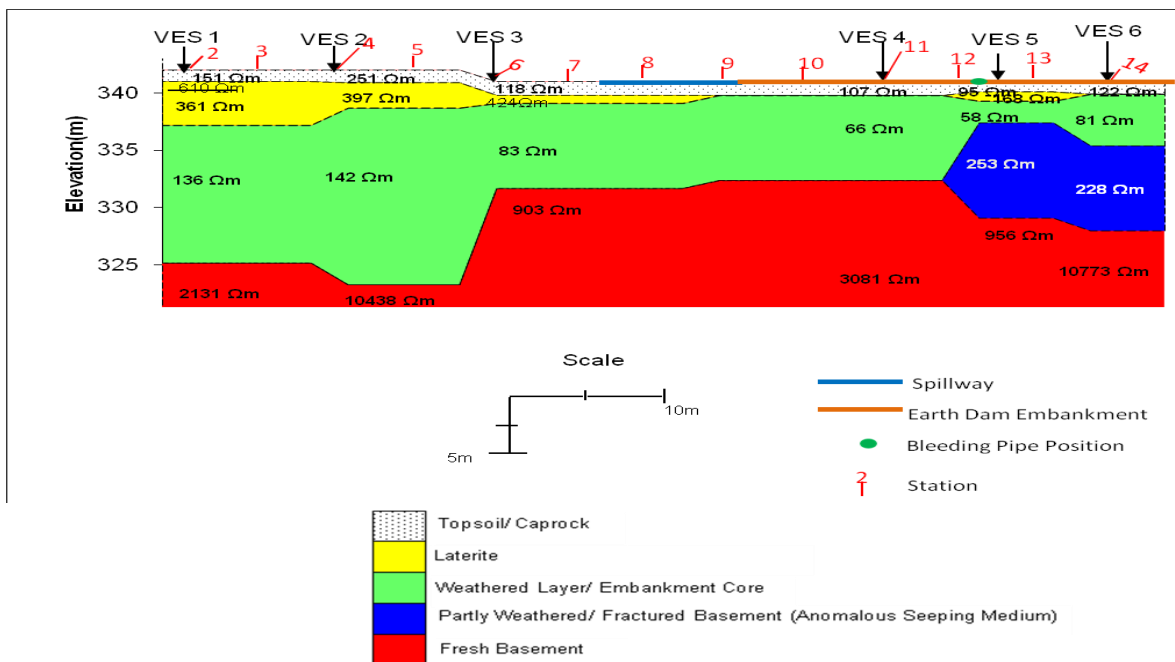
Figure 7: Geoelectric Section Beneath Mokuro Dam-Site.

The geoelectric section (Figure 7) delineates a maximum of five (5) geologic layers beneath the dam embankment. The first layer is the topsoil/caprock with resistivities and thicknesses of between 361 and 251 Ωm and 0.9 and 1.3 m respectively. The second layer is the lateritic layer with resistivities of between 361 and 1680 Ωm

and thicknesses of between 0.7 and 3.8 m. The third layer which represents the embankment core shows resistivity and thickness ranges of 58-142 Ωm and 1.1-16.6 m, respectively. The fourth layer is a partly weathered/fractured basement with resistivities of between 228 and 253 Ωm and thicknesses of between 7.4 and 8.3 m. The last layer is the basal fresh basement bedrock with a resistivity range of 903-10773 Ωm .

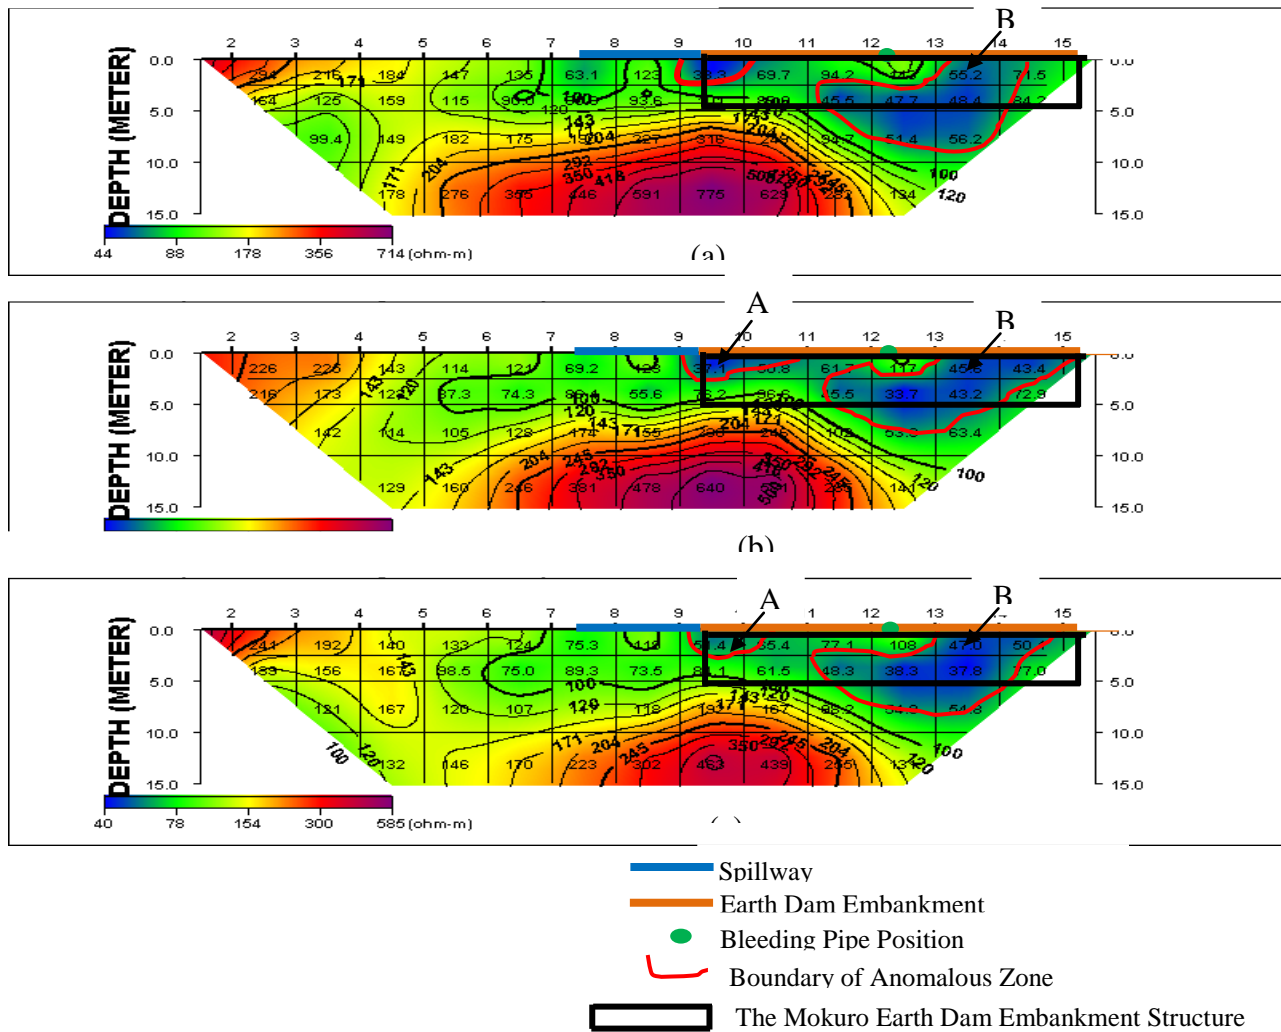
Figure 8: The 2-D Electrical Image (a) After a Discharged Artificial Lake, (b) Two Weeks after Artificial Lake was Restored, (c) Three Months After Artificial Lake Was Restored.

Two anomalously low resistivity (34-51 Ωm) zones (designated A and B) suspected to be precipitated by seepages through the interface between the spillway and the embankment, and the metallic bleeding pipe/partly weathered/fractured basement beneath the embankment were delineated on all the 2-D resistivity structures (Figures 8a-c). The depth extent of both anomalous zones remain virtually the same (about 2.5 m and 7.5 m, respectively) irrespective of the status of the artificial lake. However, the lateral extent of anomalously low resistivity zone A delineated between stations 9-10.2 when the lake was discharged (Figure 8a) may have changed slightly. Similarly, the anomalous zone B initially identified between stations 11-14 in Figure 9 a extends laterally to station 15 in Figures 8 b and c.

The Mokuro Earth Dam Embankment has design specifications of 30 m length and 5 m depth of core as delineated on the 2-D images in Figures 8 a-c. The resistivity images indicate that the embankment has anomalous seepage zones both within and beneath the dam embankment. About 50% of the embankment core shows evidence of anomalous seepages. The images of the anomalous seepages increase laterally after the restoration of the dam lake, indicating that the rehabilitation works carried out on the embankment upstream has no significant effect.

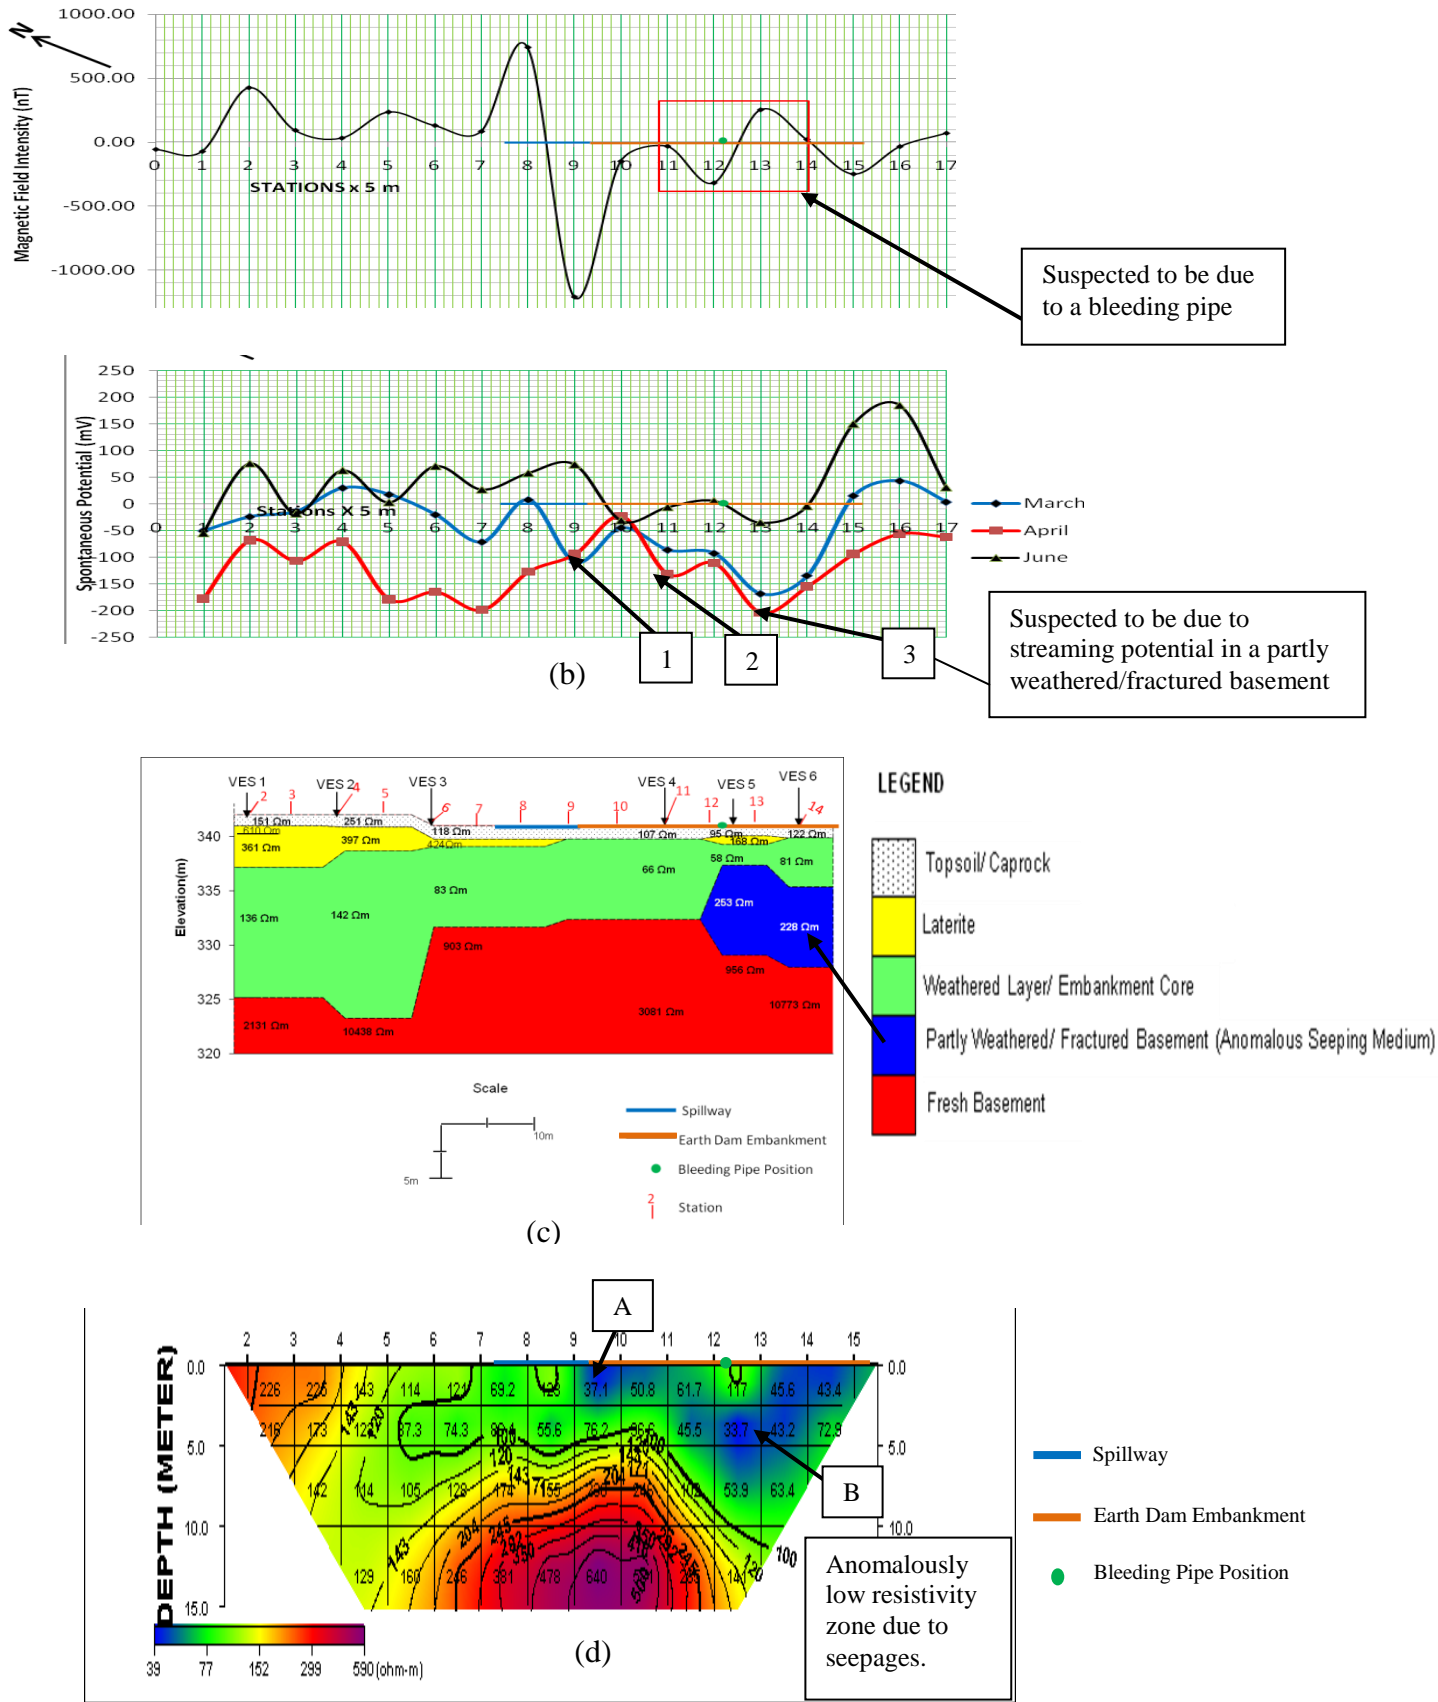
Figure 9: Synthesis of Results. (a) Magnetic Profile, (b) SP Profiles, (c) Goelectric Section, and (d) 2-D Resistivity Structure.

The black arrows in Figure 9 (a-d) serve the purpose of showing the principal anomalous zones identified by the magnetic, SP, and electrical resistivity (VES and dipole-dipole) methods along the crest of the dam embankment that are suspected to be associated with seepages and seepage structures. There is significant correlation in the positions of the identified anomalous zones. All the methods identify anomalous zones between stations 11-14.

The blocked out magnetic signature between stations 11 and 14 (Figure 9 a) is due to a metallic bleeding pipe located at a depth of about 2.5 m within the dam embankment. The magnetic signature was not expected to map non-metallic seepage path. The peak negative SP anomaly (1) at station 9 may have mapped the water seepage precipitated by the interface between the spillway and the dam embankment which could have resulted in the anomalously low resistivity zone A on the

2-D resistivity structure (Figure 9 d). The peak negative SP anomaly (2) at station 11 could have emanated from the bleeding pipe whose response is superimposed on the streaming potential (SP anomaly 3) from a seepage precipitating partly weathered/fractured basement identified on the geoelectric section in Figure 9 c and as anomalous zone B on the resistivity structure (Figure 9 d).
