Geophysical Investigation of a Suspected Foundation Failure at Ogbomoso, Southwestern, Nigeria.

A geophysical investigation was carried out around the abandoned Ogbomoso North Local Government Secretariat Complex Building with a view to identifying the cause(s) of the failure of the foundation of the building.

It is suspected that the failure of the building foundation may have been precipitated by differential settlement within the suspected faulted zone.

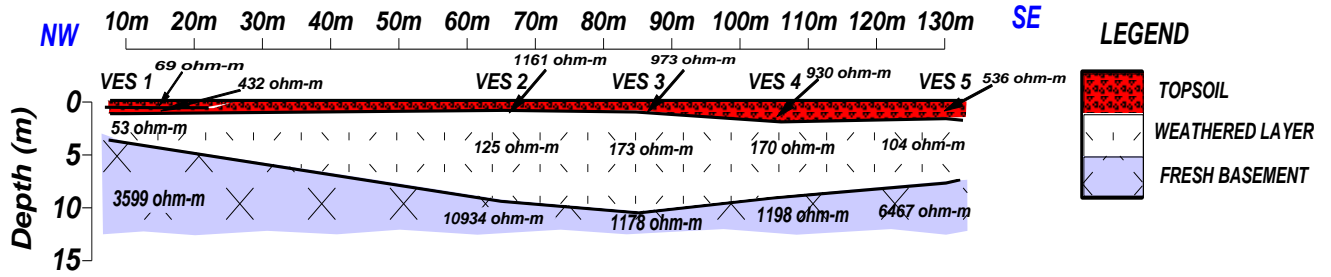
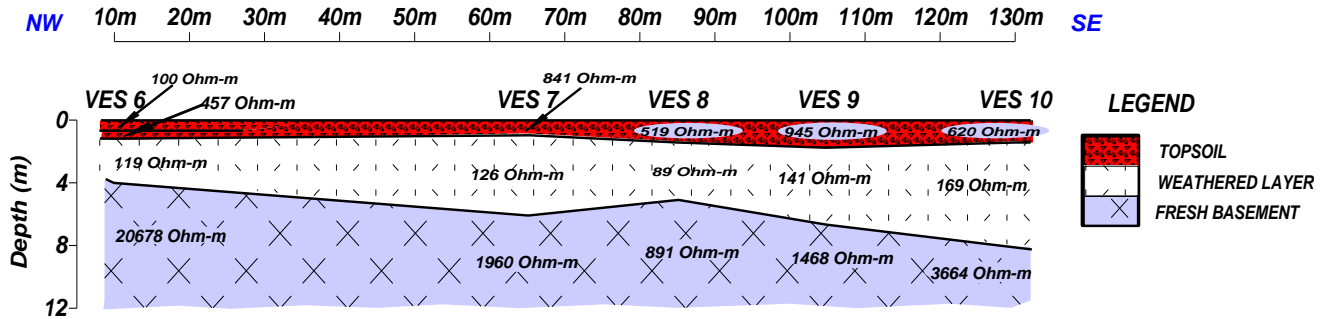
Figure 4a: Geoelectric Section Beneath Traverse 1(a), and 2 (b) relating VES 1 – 10.

The 2-D geoelectric sections along the four traverses (Figures 4(a-d)) delineate four subsurface geologic units which comprise the topsoil, weathered layer, partly weathered/fractured basement and the fresh

basement bedrock. The topsoil has resistivity values that vary from 69 – 1161 ohm-m and thickness values ranging from 0.4 – 1.8 m. It is composed of clay, sandy clay, clayey sand and laterite. The second layer is the weathered layer. It is characterized by resistivity values ranging from 34 – 364 ohm-m and thicknesses varying from 0.7 – 10.1 m. It is composed of clay and sand clay. The partly weathered/fractured basement third layer (beneath VES 14 and 19) has layer resistivity values of 27 – 784 ohm-m and thicknesses of 2.5 to 4.2m. The basement bedrock which is fresh in most places has layer resistivity values of 724 – 18176 ohm-m. The depth to the geoelectric bedrock varies from 3.2 to 15 m.

The interface between the weathered layer and the basement bedrock is gently undulating. Depth to the basement bedrock is between 10 – 15 m. A vertical discontinuity which manifests as anomalously low resistivity zone within high resistivity zone and suspected to be a fault, is located beneath VES 4 (between distances 95 – 110 m). This suspected linear feature has a depth extent of up to 30 m. The 2-D image significantly correlates with the geoelectric section along this traverse (see Figure 4a).

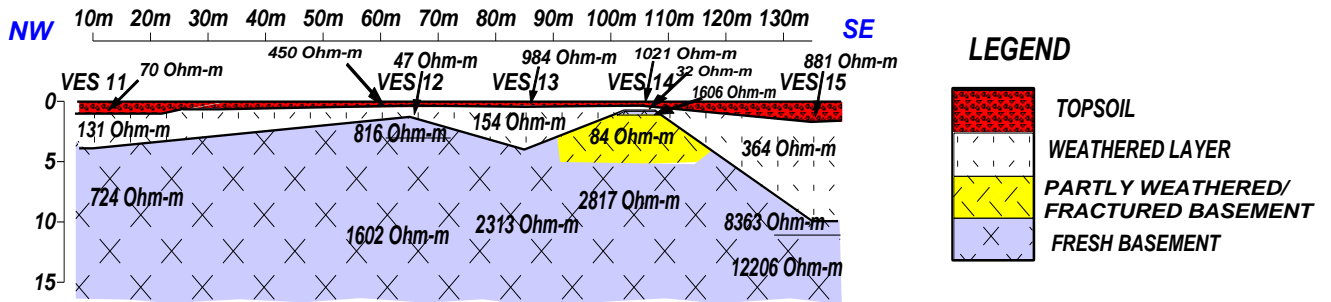
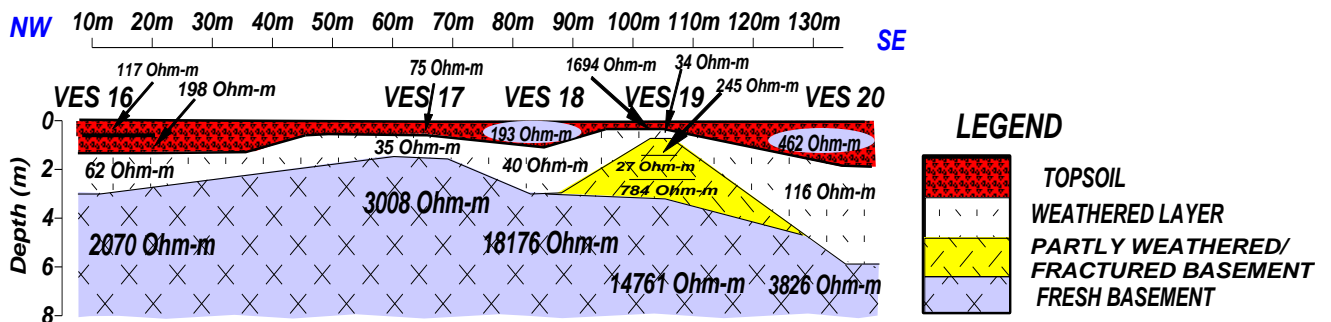
Figure 4b: Geoelectric Section Beneath Traverse 3(c) and Traverse 4(d) relating VES 11 – 20.

layer resistivity ranges in value from 100 – 362 ohm-m. The overburden thickness averages about 5 m. A major vertical discontinuity exists beneath VES 14 (between distances 85 – 115 m). It manifests as a low resistivity zone within a high resistivity basement bedrock. This feature is characteristic of a fault. VES 14 identifies a confined fractured basement column (see Figure 4c). The 2-D image correlates significantly with the geoelectric section developed along this traverse (see Figure 4c).

Except for the delineation of confined fractured basement columns beneath VES 14 and 19, the geoelectric sections did not identify the vertical discontinuity suspected to be faults within the basement. This could be explained from the point of view of the 1-D nature of the VES data and its interpretation model.

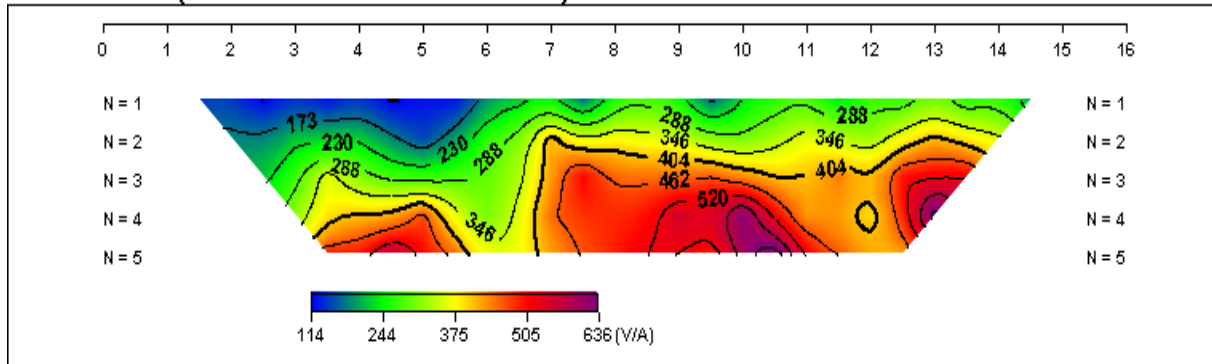
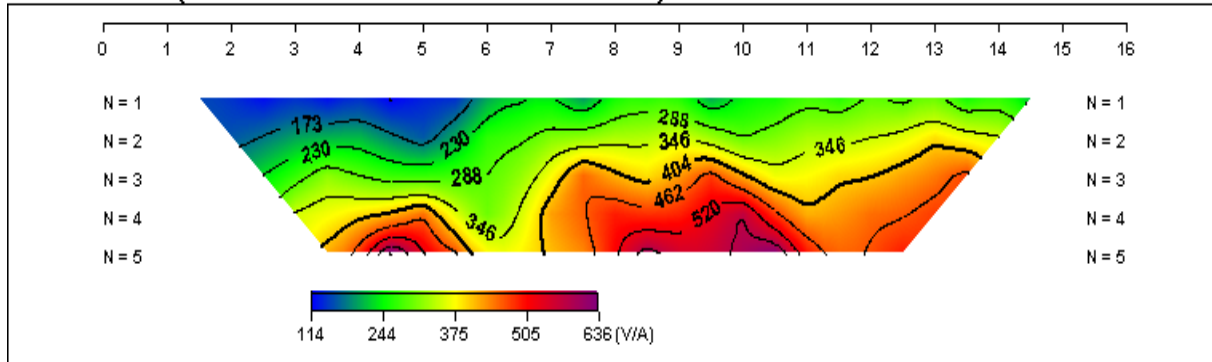
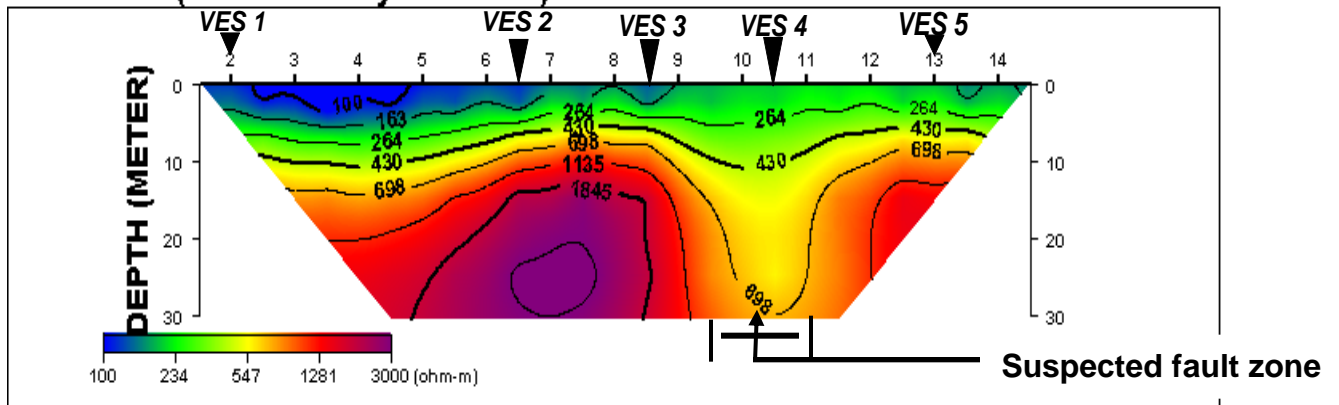
Figure 5: Dipole-Dipole Pseudosection along Traverse 1 with VES 1 - 5.

The 2-D resistivity structure beneath Traverse (TR 1) (Figure 5) displays a thin (<2m) and clayey topsoil with resistivity values of <100 ohm-m. The weathered layer, in green color, has resistivity values of between 100 and 500 ohm-m with average thickness of about 10m. The basement bedrock has resistivity values greater than 500 Ohm-m and in yellowish/reddish/purple color band.

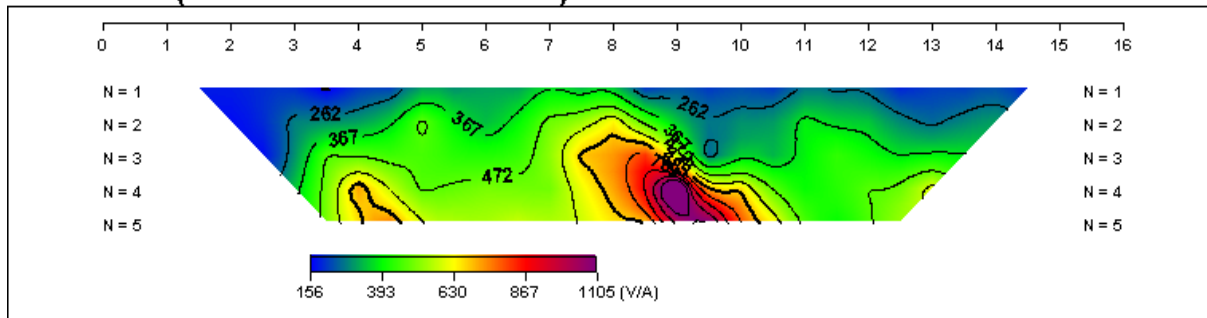
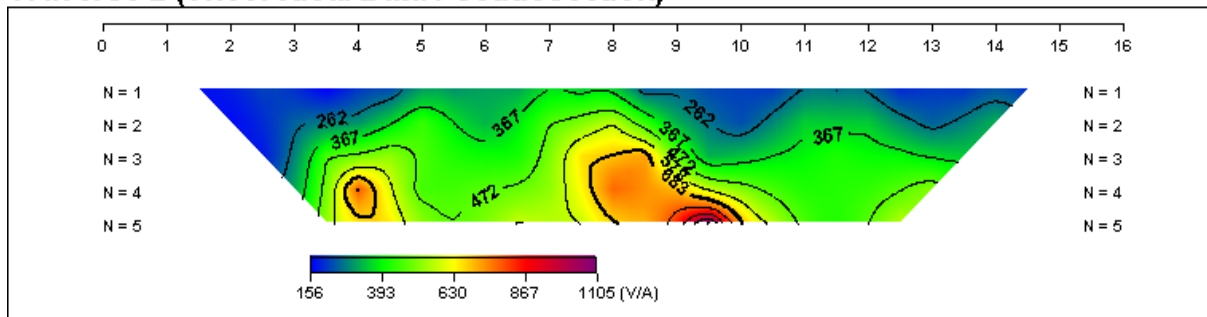
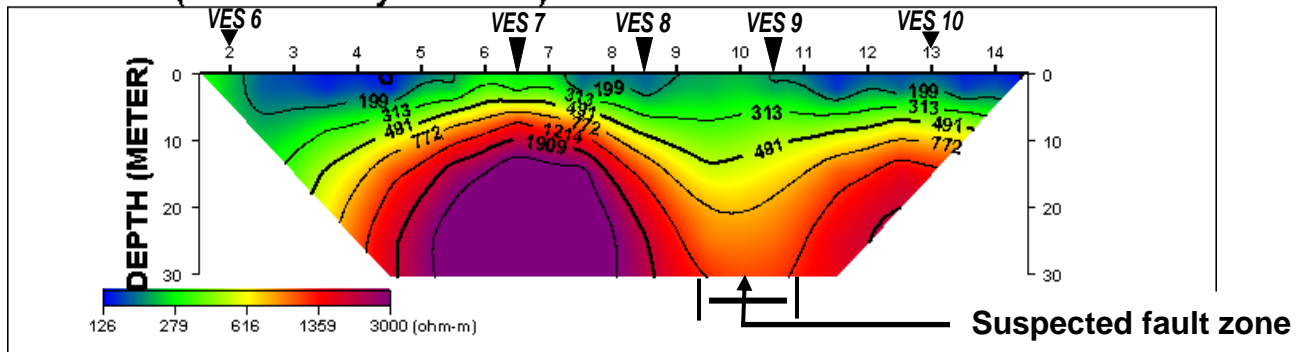
Figure 6: Dipole-Dipole Pseudosection along Traverse 2 with VES 6 – 10.

The 2-D resistivity structure beneath Traverse TR2 (Figure 6) also displays a relatively thin (average of about 2.5 m) topsoil with relatively low resistivity values of < 200 ohm-m. The weathered layer, in green color band, has layer resistivity of 200 – 500 ohm-m. The interface between the weathered layer and the basement bedrock is undulating with overburden thickness varying from about 5 – 15 m. The basement bedrock has resistivity values that are greater than 500 ohm-m. A vertical discontinuity, also suspected to be a fault, exists beneath VES 8 & 9 (between distances 90 – 110m) along the traverse line. The depth extent seems greater than 30m. The 2-D image correlates significantly with the geoelectric section (see Figure 4b).

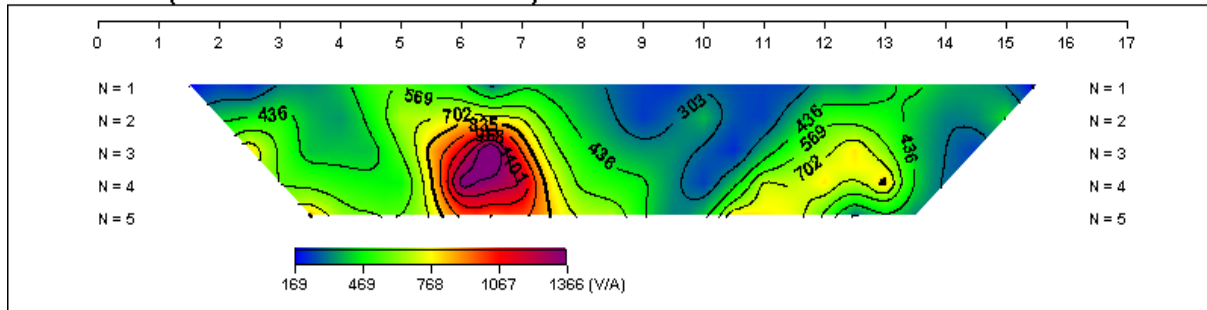
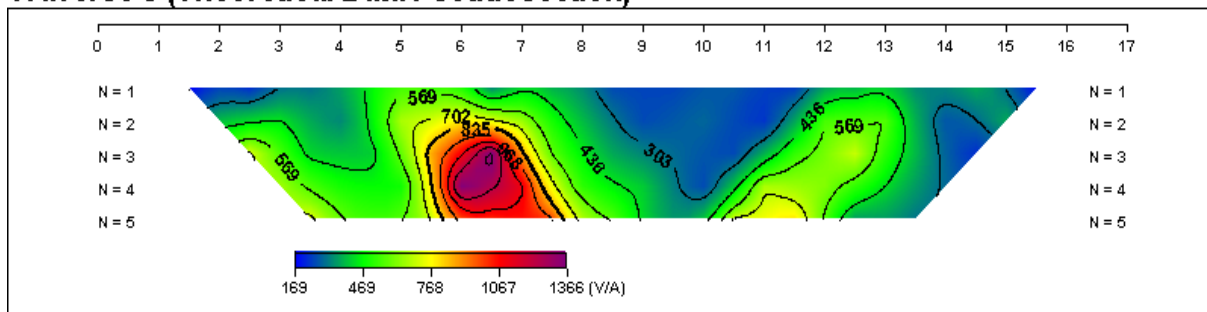
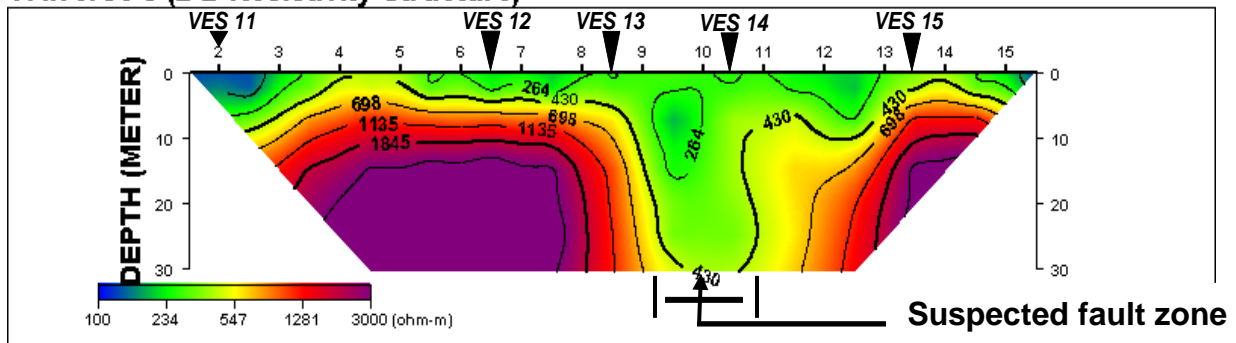
Figure 7: Dipole-Dipole Pseudosection along Traverse 3 with VES 11 – 15.

The 2-D resistivity structure beneath Traverse TR3 (Figure 7), shows a topsoil that is generally very thin (<1) and virtually merges in resistivity range with the weathered layer. The weathered

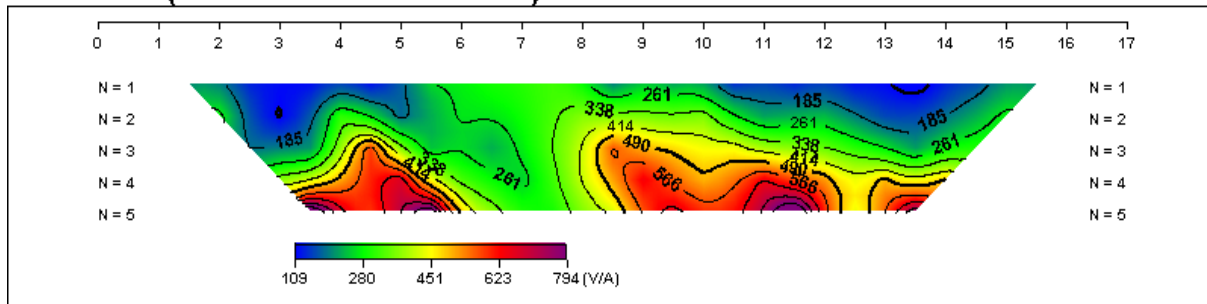
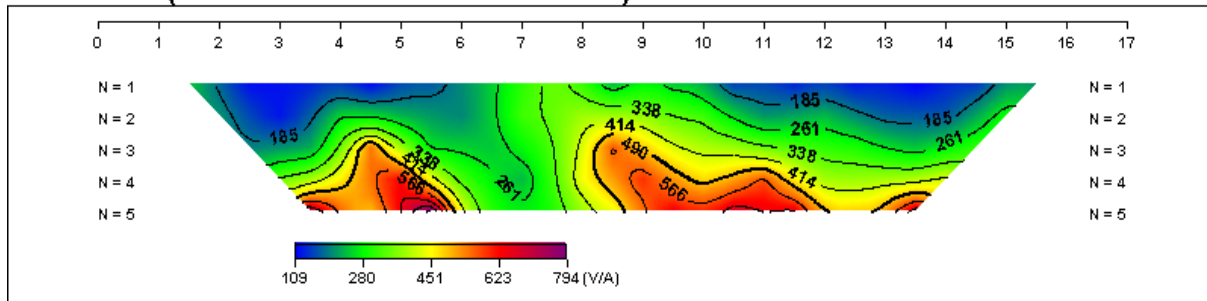
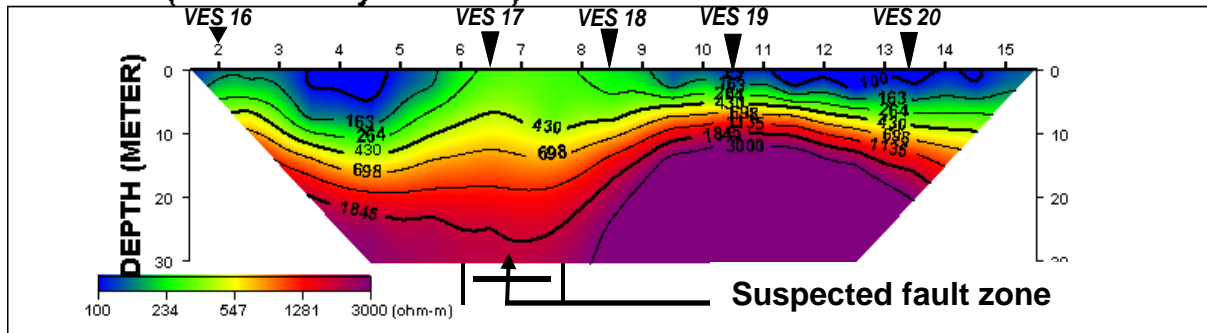
Figure 8: Dipole-Dipole Pseudosection along Traverse 4 with VES 16 – 20.

The 2-D resistivity structure beneath Traverse TR 4 (Figure 8) shows a topsoil with resistivity of <100 ohm-m with an average thickness of about 2.5 m thick. The weathered layer with resistivity of up to 500 ohm-m overlies the basement bedrock at depths ranging from about 10 – 16 m. The basement bedrock interface is gently undulating.

A shadow of what looks like a minor vertical discontinuity occurs between VES 17 and 18 (between distances 65 and 85 m). The suspected fault zone may not be well defined along the traverse because its orientation is at low angle to the traverse line (see Figure 10)

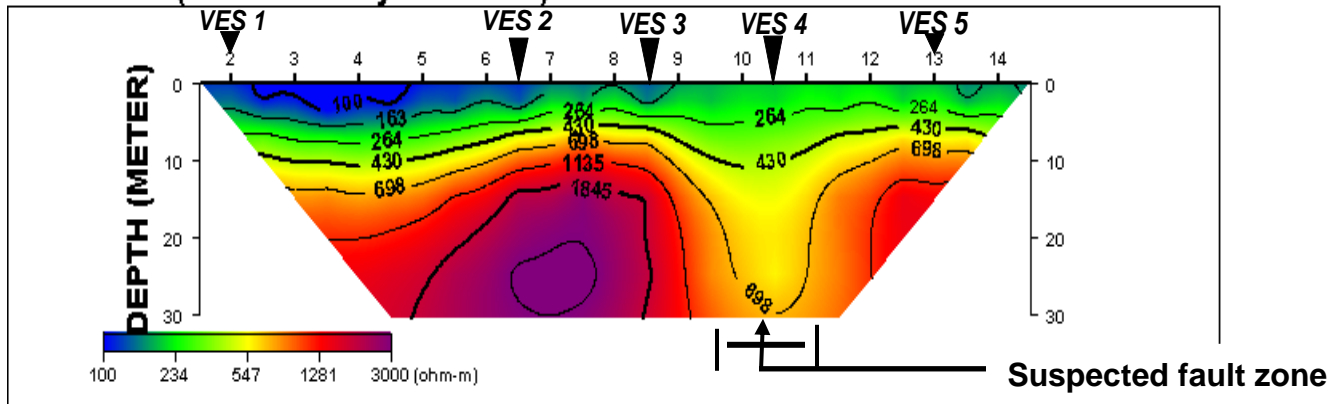
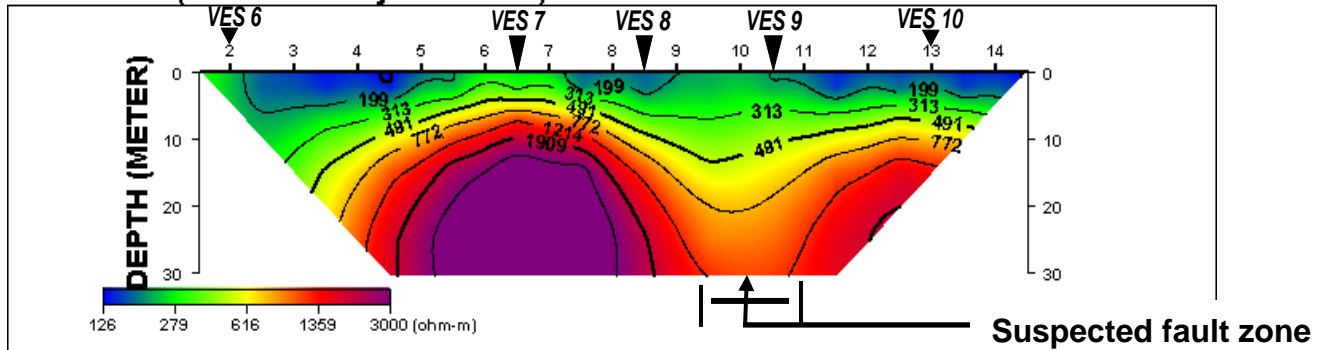
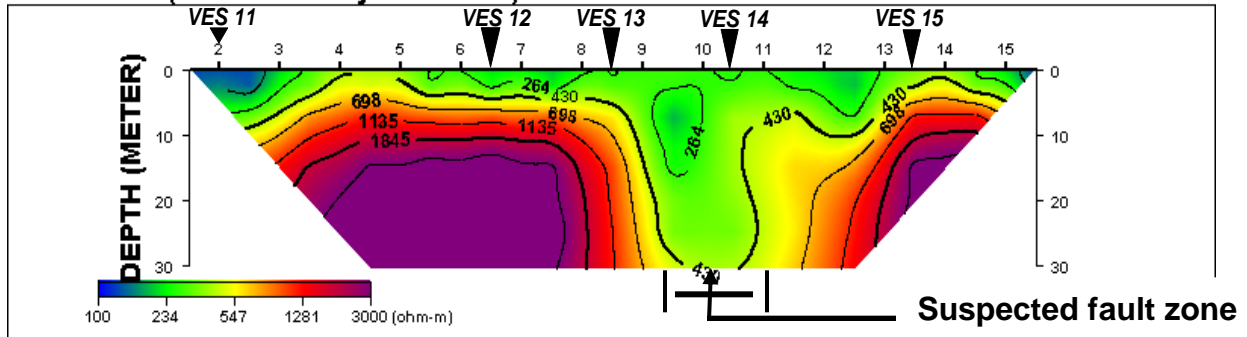
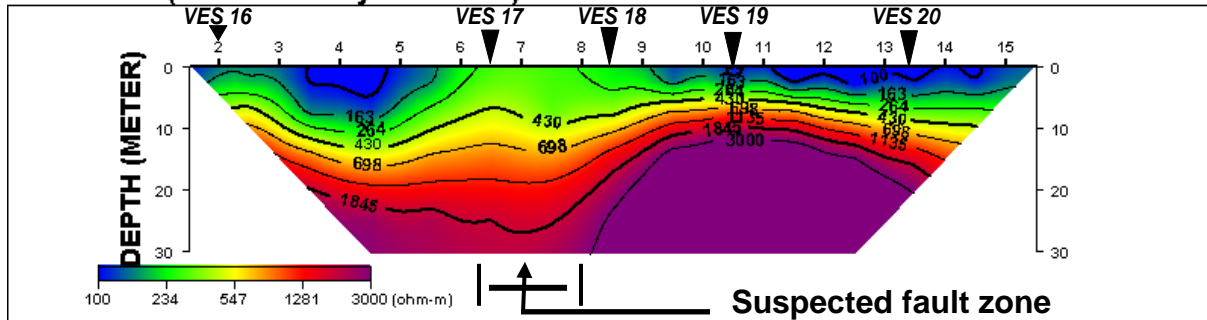
Figure 9: Correlation of the Faulted Zone along Traverses 1 – 4.

Figure 9 correlates the faulted zone across resistivity structures obtained beneath Traverses 1 – 4. Figure 10 displays the suspected linear structure (fault) in plan. The failed segment of the building is located within the zone. The foundation failure may have been precipitated by settlement within the suspected fault zone. The failed segments of the NNPC filling station wall in the northwestern flank of the survey area fall within the projection of the faulted zone, corroborating the inference above (see Figure 10).

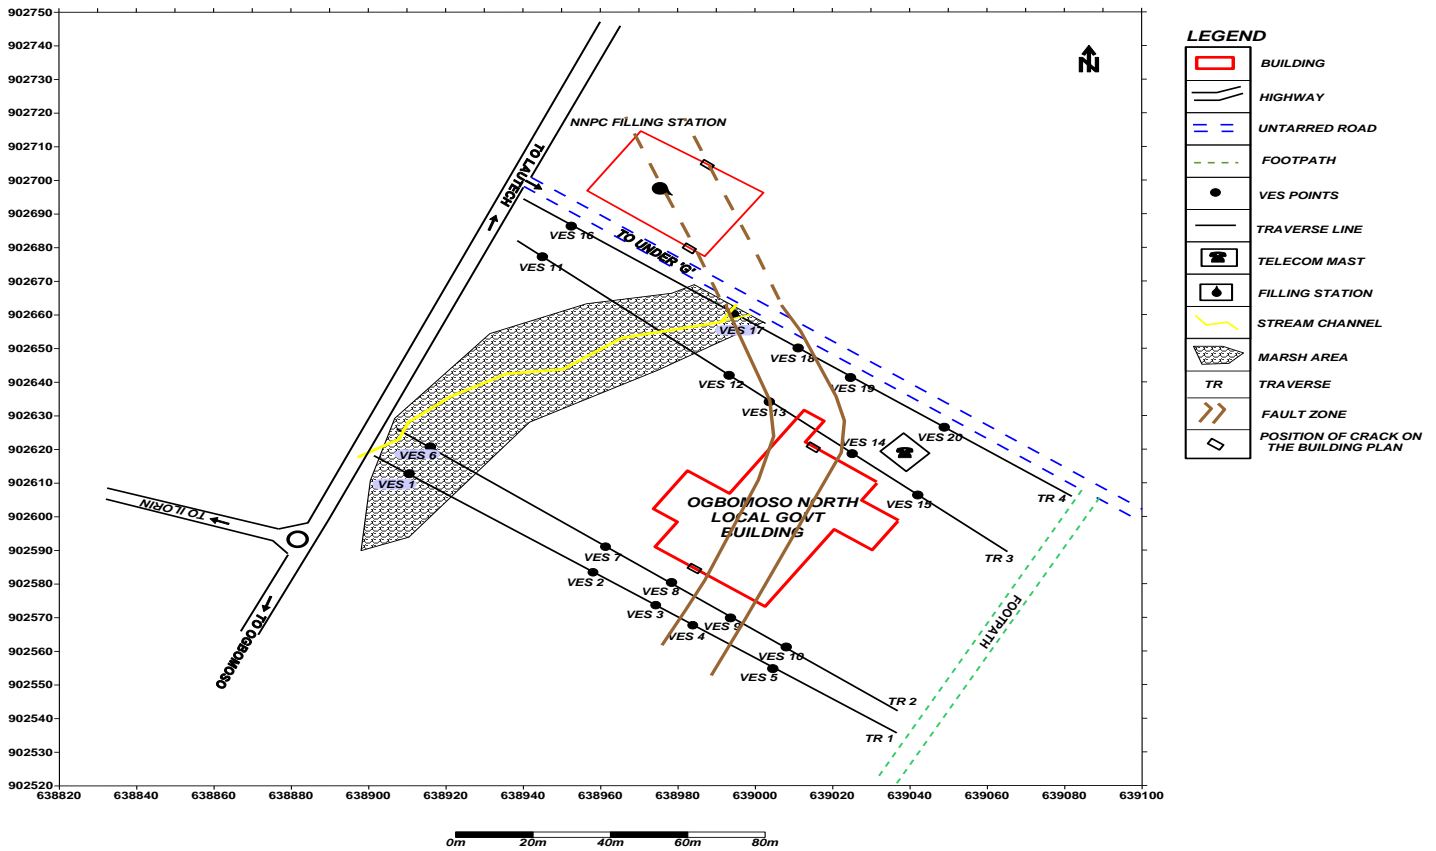
Figure 10: Structural Map of the Study Area.

The 2-D images delineate three major subsurface layers – a topsoil (generally in blue color band), the weathered layer (in green color band) and a basement bedrock (in yellowish/reddish/purple color band). The resistivity structures identify a major linear feature suspected to be a fault that cut across the building site. The faulted zone is about 20 – 30 m wide. It is suspected that the failure of the building foundation may have been

precipitated by differential settlement within the suspected faulted zone.
