Analysis of Error in a Very High Frequency Omni-directional Radio Range (VOR) Station in an international Airport in Nigeria

This work investigates the degree of error in a Very High Frequency Omni directional Radio Range (VOR) transmitter at an International Airport in Nigeria. The investigation involved the acquisition of a twelve-month measurement error in transmitters I and II of the VHF, Omni directional Radio Range (VOR) system present at the airport and subsequent analysis using Graph-pad prism 5.01. VHF Omni directional Radio Range enables the pilot to take - off and land safely.

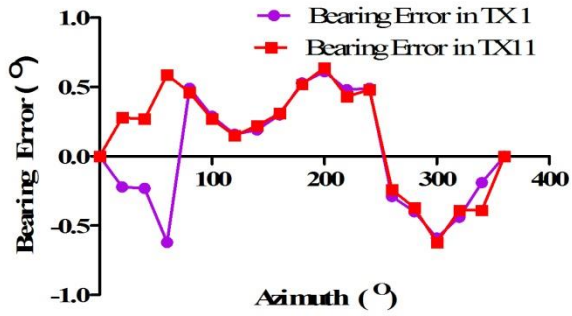
(a)

Figure 3(a) had maximum error of $\pm 0.64^\circ$ with an error spread of 1.28° . It was further observed, that, errors of $+0.5^\circ$ & -0.29° were obtained at Azimuths of: 80° & 260° , respectively. These, implied that, the actual courses radiated along the radials of 80° & 260° were: 79.5° & 260.29° , respectively. Figure 3(b) had maximum error of $\pm 0.62^\circ$ and an error spread of 1.25° . At azimuths of 100° & 260° , respective errors of $+0.24^\circ$ & -0.27° were obtained, thus, resulting in actual course radiations in the direction of 99.76° & 260.27° , respectively.

Comparatively, the highest maximum error of $\pm 0.64^\circ$ and a highest error spread of 1.28° were obtained from Figure 3(a), while, the least maximum error and least error spread of $\pm 0.59^\circ$ and 1.2° were obtained from Figure 3(f). These signified that, the signal radiation from the VOR base station, suffered the highest and the least interference in months of January and June respectively. However, for angles of elevation between 0° & 40° , all of the maximum errors recorded were within the ICAO's stipulated $\pm 2^\circ$ ground station error contribution to the uncertainty in the bearing information resulting from horizontally polarized radiation from the centre of the VOR antennas.

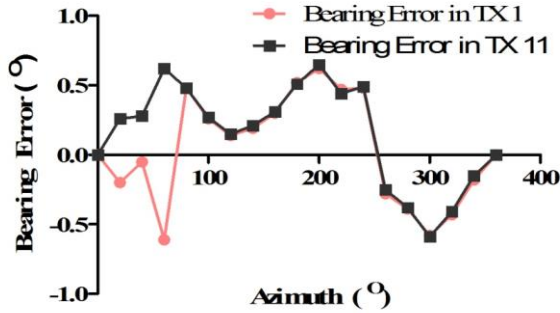
(c)

The VOR ground check error curve in Figure 3(c) had maximum error of $\pm 0.615^\circ$ with error spread of 1.24° . Similarly, errors of $+0.48^\circ$ & -0.28° were obtained at Azimuths of: 80° & 260° , respectively. These, denoted that, the actual courses radiated along the radials of 80° & 260° were 79.52° & 260.28° , respectively.

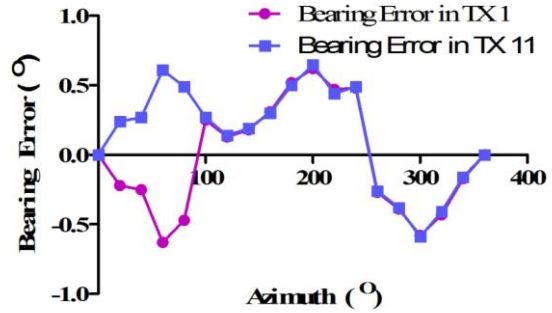
(d)

Figure 3(d) had maximum error of $\pm 0.62^\circ$ and error spread of 1.26° . Further observation of figure 4(d) revealed that, errors of $+0.25^\circ$ & -0.29° were obtained at Azimuths of: 100° & 260° , respectively. These, imply that, the actual courses radiated along the radials of 100° & 260° were 99.75° & 260.29° , respectively.

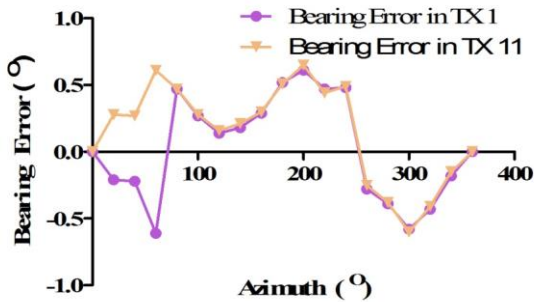
(e)

Furthermore, in Figure 3(e) the VOR ground check error curve has maximum error of $\pm 0.61^\circ$ and spread error of 1.23° with errors at Azimuths of 80° & 260° obtained as $+0.47^\circ$ & -0.28° . These indicated that the actual courses

at those azimuths were 79.53 79.53° & 260.28° , respectively. Furthermore, it was observed that, the ground error check curve in Figure 4(f) does not only have a maximum error of $\pm 0.59^\circ$ but also, error spread of 1.2° . Errors of $+0.24^\circ$ & -0.27° were obtained at azimuths of 100° & 260° , respectively. These values, signify actual course radiations of 99.76° & 260.27° , respectively, instead of 100° & 260° .

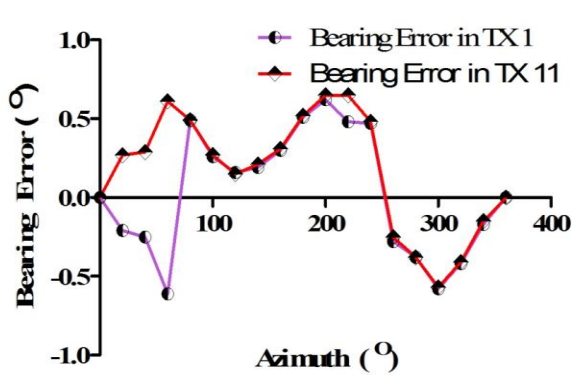
(g)

A maximum error of $\pm 0.63^\circ$ and an error spread of 1.28° were deduced from Figure 4(g). It was observed that, at Azimuths of: 80° & 260° , errors of: $+0.49^\circ$ & -0.28° were obtained, respectively, which resulted in actual course radiation of: 79.51° & 260.28° , respectively along those Azimuths.

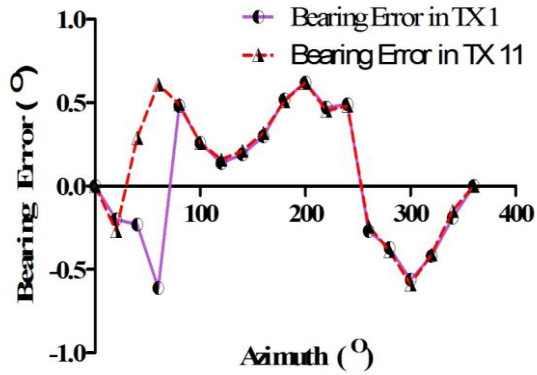
(h)

Figure 3(h) had maximum error of $\pm 0.62^\circ$ and an error spread of 1.26° . In addition, it also had errors of: $+0.48^\circ$ & -0.26° at Azimuths of: 80° & 260° , respectively, which implied that: 79.52° & 260.26° were the actual course radiations along Azimuths: 80° & 260° , respectively. However, there appears to be a periodic variation between Azimuths of 0° & 30° . According to ICAO 8071 such periodic variation could be attributed to malfunctioning equipment or improper adjustment of equipment.

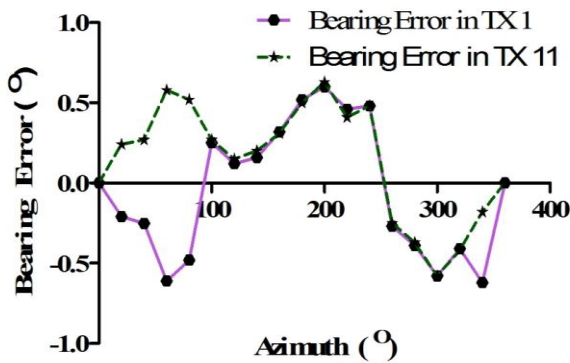
(i)

Similarly, the VOR ground check error curve in Figure 3(i) had maximum error and error spread of $\pm 0.62^\circ$ & 1.25° , respectively. At Azimuths of: 100° & 260° , errors of: $+0.25^\circ$ & -0.27° were obtained, respectively, which indicated that, the actual courses radiated along the radials of 100° & 260° were 99.75° & 260.27° , respectively.

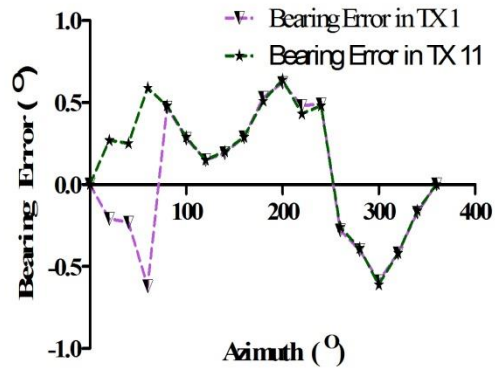
(j)

Figure 3(j) had maximum error of $\pm 0.63^\circ$ and error spread of 1.28° with errors at Azimuths of 80° & 260° obtained as $+0.47^\circ$ & -0.28° . Thus, resulting in actual course radiations of: 79.53 79.53° & 260.28° , respectively along the Azimuths.

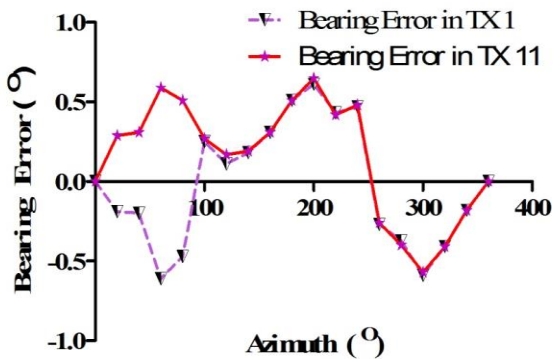
(k)

A maximum error of $\pm 0.60^\circ$ and error spread of 1.2 were obtained from Figure 3(k). At Azimuths of: 80° & 260° , errors of: $+0.49^\circ$ & -0.28° were obtained respectively, which translated in

actual course radiation of: 79.51° & 260.28° , respectively along those Azimuths.

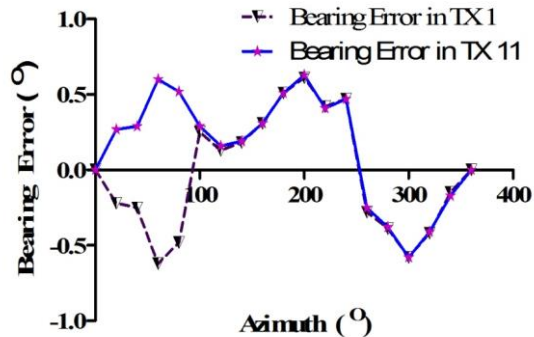
(l)

The ground error check curve in Figure 3(l) had maximum error of $\pm 0.625^\circ$ and error spread of 1.26° . In similar manner, errors of $+0.25^\circ$ & -0.28° , were obtained at Azimuths of: 100° & 260° , errors of: $+0.25^\circ$ & -0.27° , which signified that, the actual courses radiated along the radials of 100° & 260° were 99.75° & 260.27° , respectively. In accordance with ICAO 8071, the various degrees of error obtained could be attributed to slight interference from non-aeronautical transmitter.

It is therefore, recommended that, reflectors such as communication masts and tall buildings should not be sighted near NAVAIDS.
