Environmental Impact on Engineering Materials: Galvanized Steel.

ABSTRACT

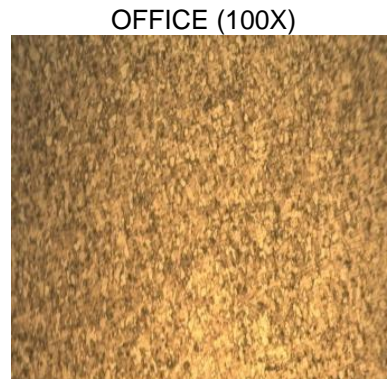
Figure 2: Micrographs of 1st Test.

The micrographs illustrate the structural components which are pearlite [darkish and hard] and ferrite [whitish and soft.]. Before exposure, [control sample], it was observed that the structure has more Pearlite than the ferrite. As the corrosion increases or corrosion rate, the ferrite begins to grow although in small quantities which has little effect on the materials. That means the corrosion rate is proportional to the duration of exposure and environment which is being exposed. The experiment was carried out four times at three weeks intervals on each sample at magnification of 100X magnification.

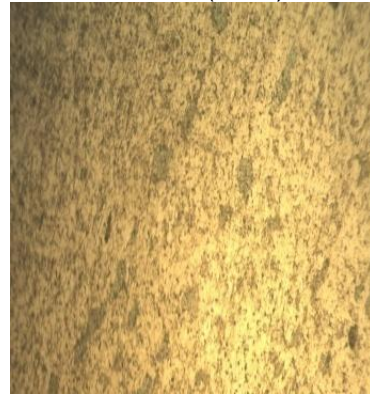
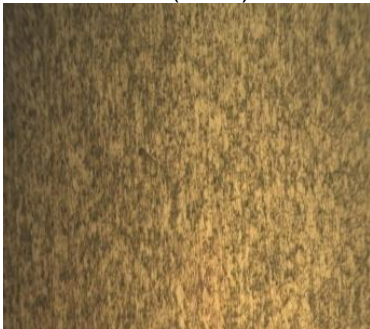
Figure 4: Micrographs of 3rd Tests.

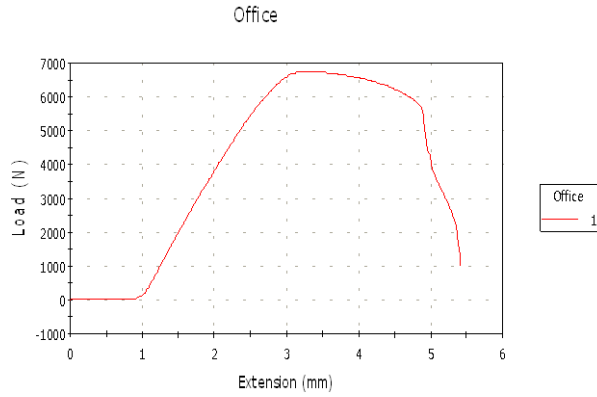
Figure 7: Tensile Graph of 1st Test Office.

The table and the graphs illustrate various tests carried out on each samples at three weeks intervals. As a result of corrosion there are variations in the mechanical properties of the materials in terms of the tensile stress, strain, load at yield load at brake, area, length elongation, etc. The graphs and tables throughout show some small variation in properties along with their values.

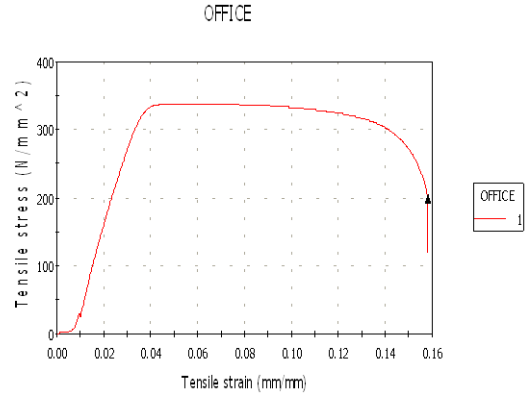
Figure 10: Tensile Graph of 2nd Test Office.

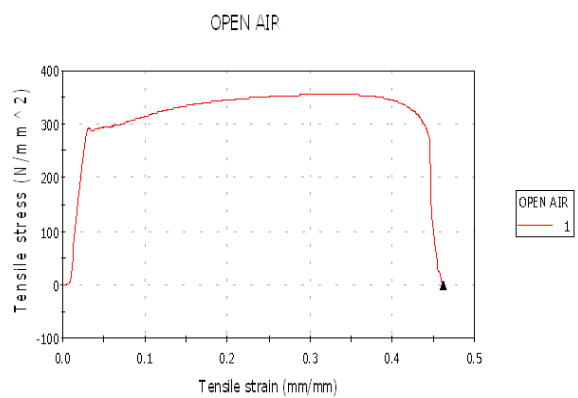
Figure 11: Tensile Graph of 2nd Tests Open Air.

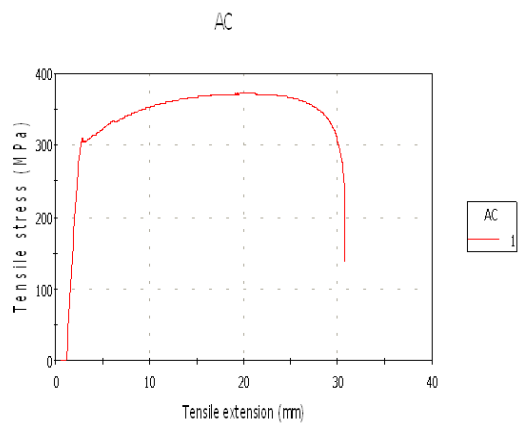
Figure 12: Tensile Graph of 3rd Tests AC.

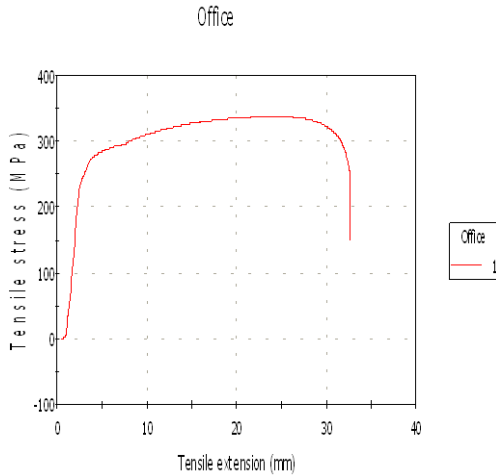
Figure 13: Tensile Graph of 3rd Tests Office.

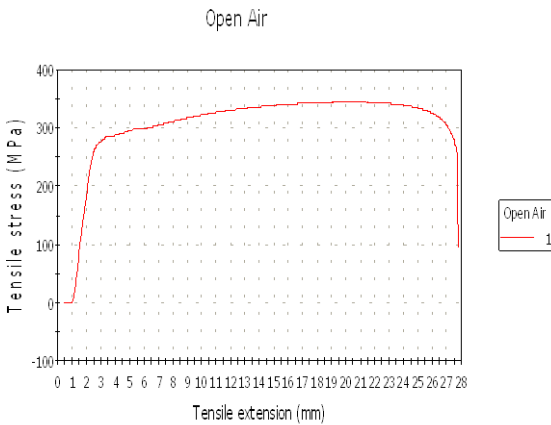
Figure 14: Tensile Graph of 3rd Tests Open Air.

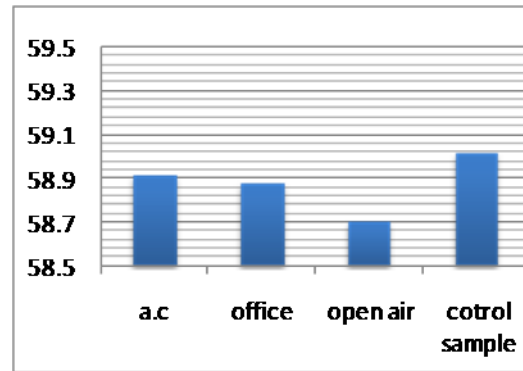
Figure 16: 2nd Hardness Test.

There were small defects in structures observed during the micro structural examination. The hardness tests were done with the aid of the Rockwell hardness tester with 60kg ball indentation and were tabulated on a bar chart in the previous page. The environmental defects were visible although with little variations because the samples were not ground and polished. The tests were carried out five times on each sample at three weeks intervals and the average was calculated to determine the reduction in the hardness value of the metals. It was observed that the air conditioning sample maintained the best hardness value compare with the control sample piece, followed by the office sample, and lastly the sample in the open air.
