Geophysical Investigation of Pavement Failure in a Basement Complex Terrain of Southwestern Nigeria.

O.J. Akintorinwa, Ph.D.^{1*}; J.S. Ojo, Ph.D.¹; and M.O. Olorunfemi, Ph.D.²

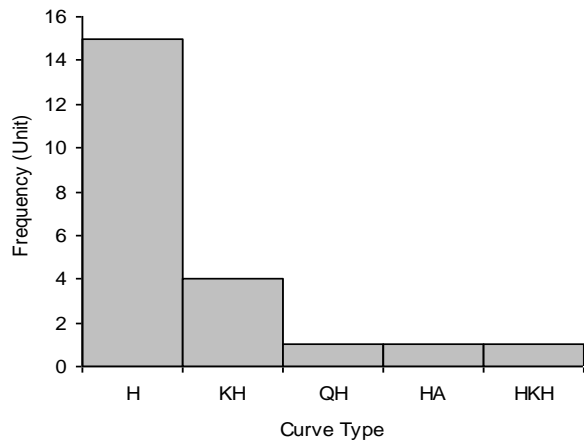
Figure 5a: Histogram of the Curve Type in the Stable 1 and 2.

The two histograms show a predominant H type curve. This implies that curve types may not be good indicators of stability of highway pavement since the stable section and failed section display predominantly the same curve types.

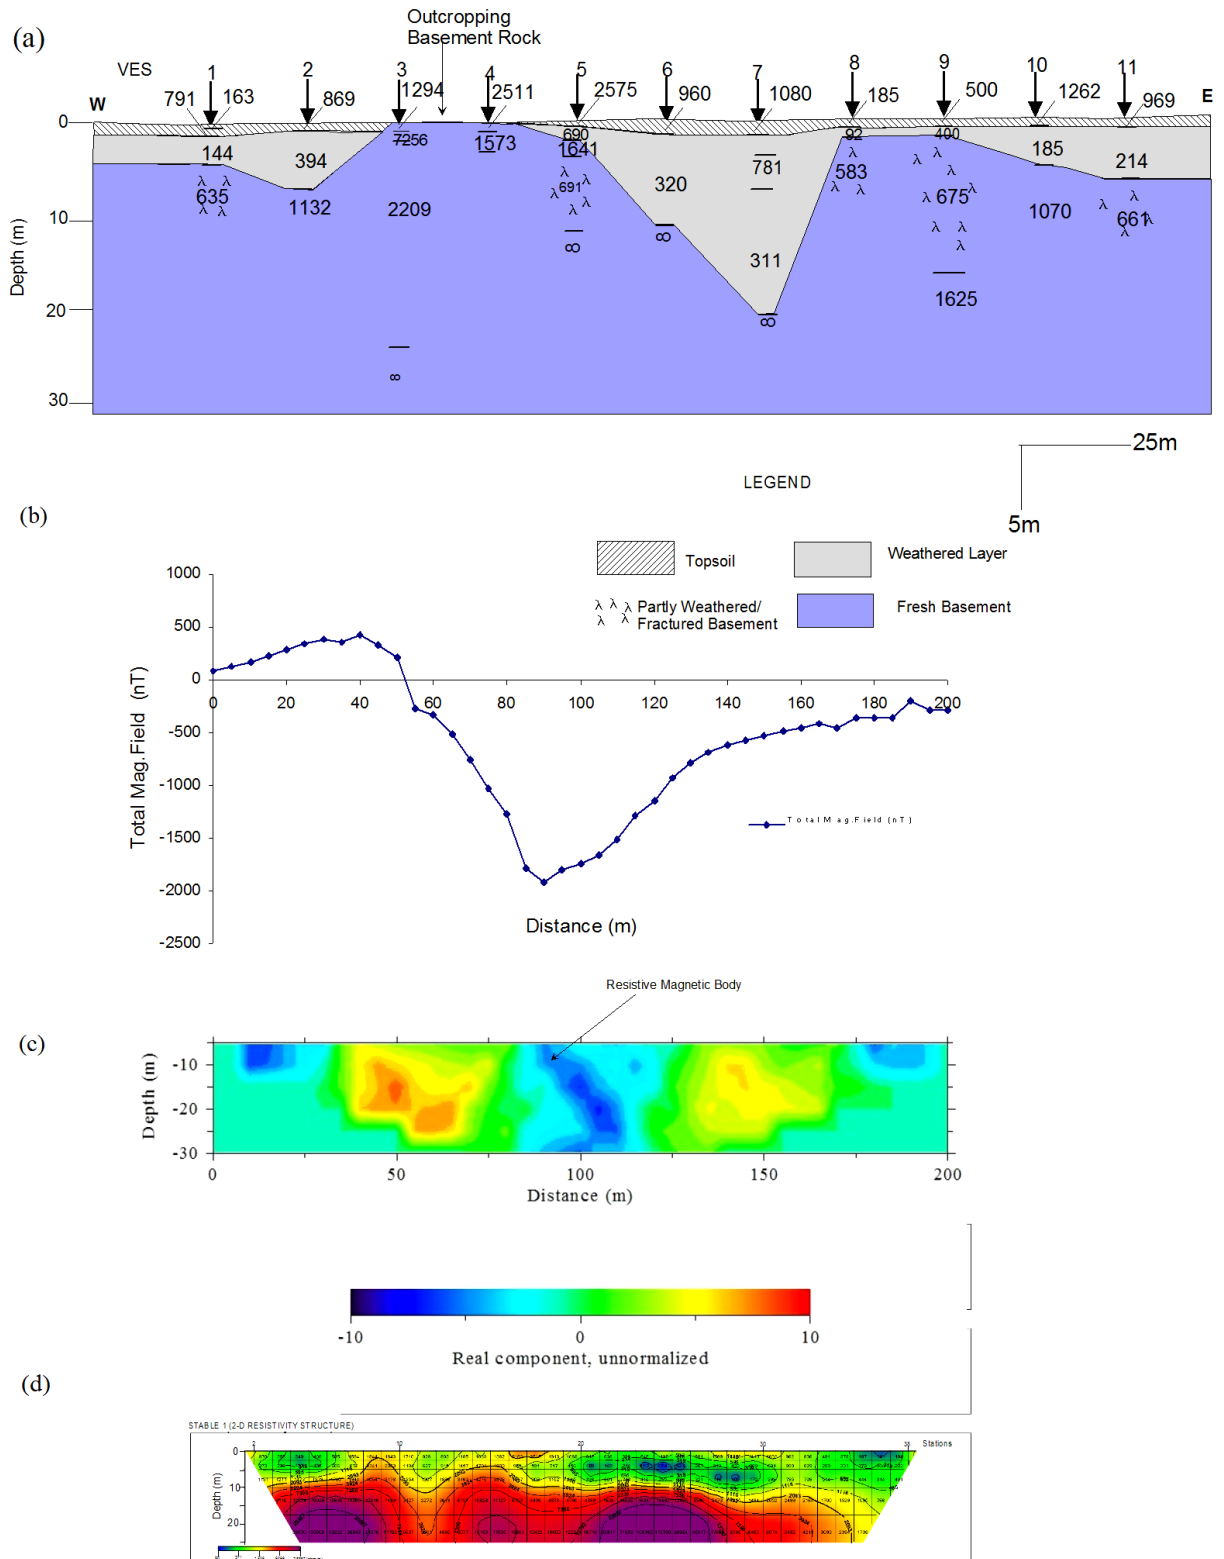
Figure 6: (a) Goelectric Section, (b) Magnetic Profile, (c) 2-D VLF Inversion Model and (d) 2-D Dipole-Dipole Resistivity Structure at Stable Segment 1.

The stable segment 1 is characterized by relatively high resistivity topsoil and weathered layer in the upper 0-5 m with resistivity values that are generally greater than 200 Ω -m (Table 1).

The subsoil layer is composed of clayey sand and laterite (Figure 6a). The major magnetic anomaly (Figure 6b) observed at this locality is due to a resistive magnetized basement intrusion whose top is located at around 80 m (Figure 6c) where the basement rock outcrops (Figure 6a and Figure 6d). The VLF-EM 2-D model (Figure 6c) identifies this magnetic body as a poorly conductive target.

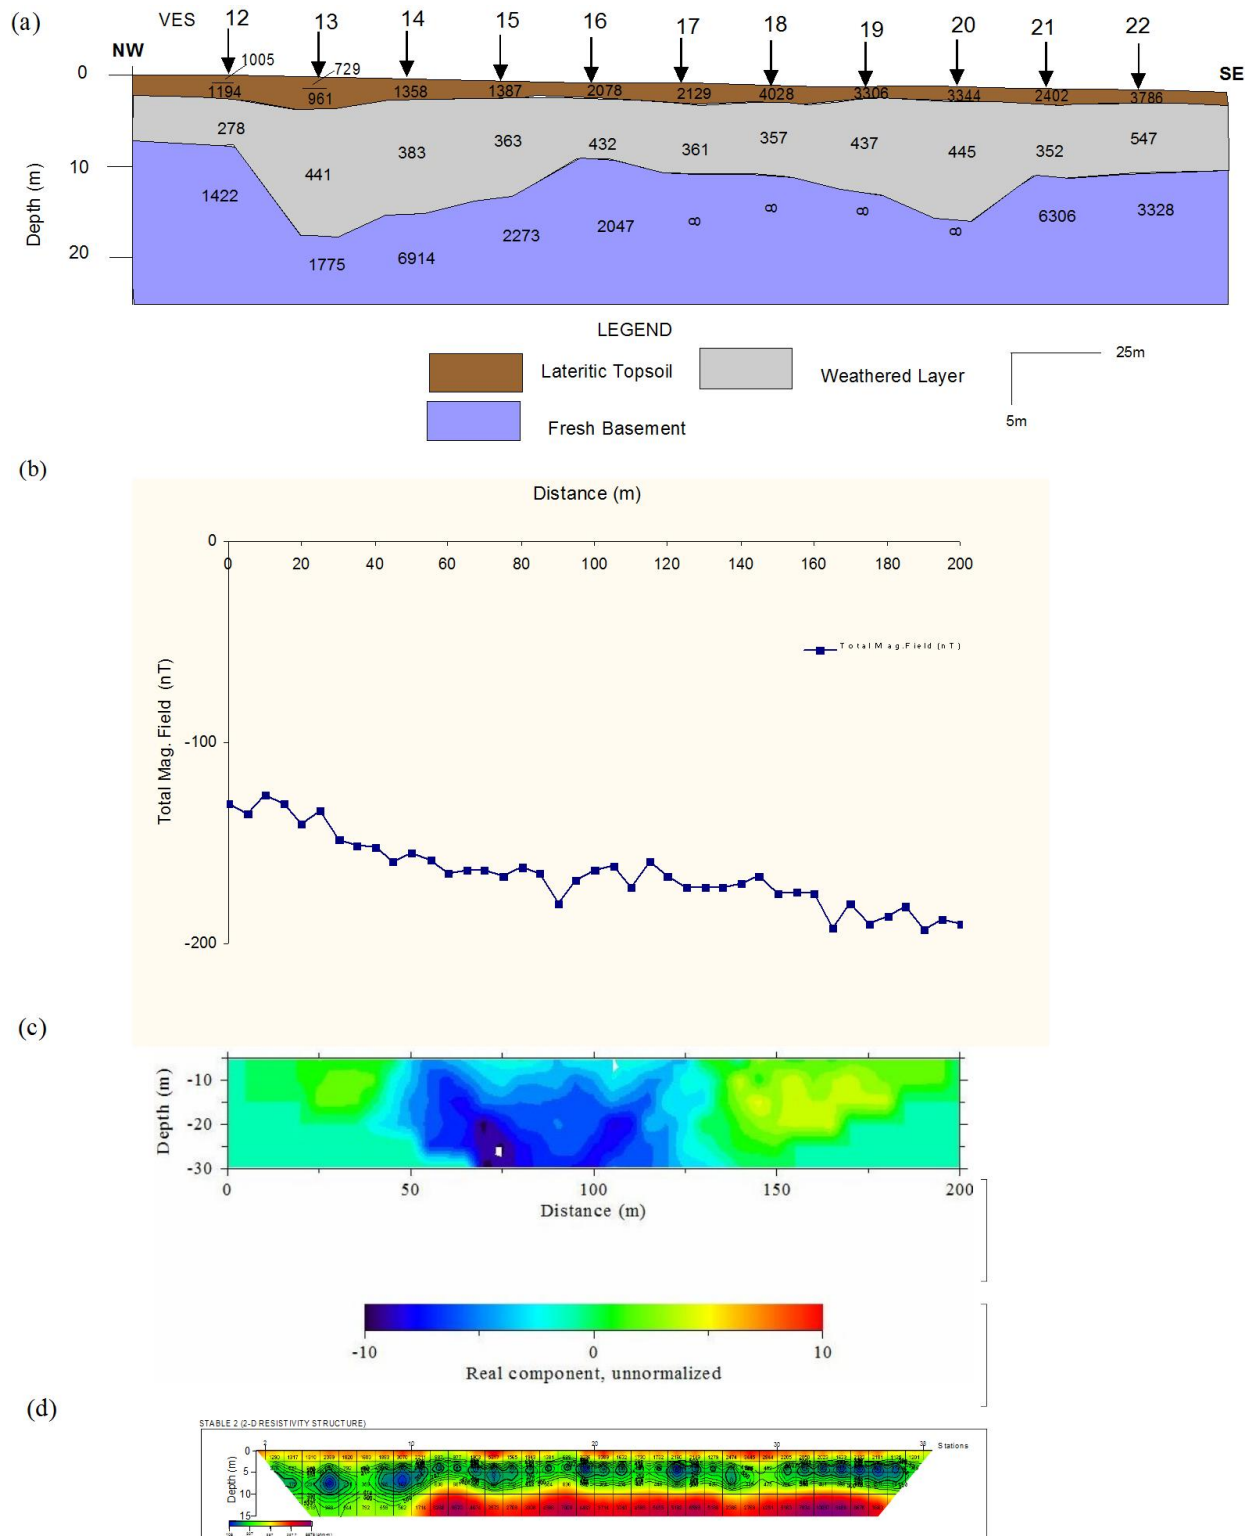
Figure 7: (a) Geoelectric Section, (b) Magnetic Profile, (c) 2-D VLF Inversion Model and (d) 2-D Dipole-Resistivity Structure at Stable Segment 2

The stable segment 2 is characterized by lateritic formation in the upper 2-3 m with resistivity values varying from 728 to 3780 Ω -m (Table 2). The underlying weathered layer is composed of clayey sand with resistivity values ranging from 278 to 547 Ω -m (7a). The relatively flat magnetic profile along this segment (Figure 7b) and a VLF-EM inverted model (Figure 7c) that is devoid of linear feature are indications of a near homogeneous subsurface sequence (Figure 7d).
