Time-Lapsed Geophysical Investigation of the Mokuro Earth Dam Embankment, Southwestern Nigeria, for Anomalous Seepages.

Akinola B. Eluwole, M.Sc. and Martins O. Olorunfemi, Ph.D.

Department of Geology, Obafemi Awolowo University, Ile-Ife, Nigeria.

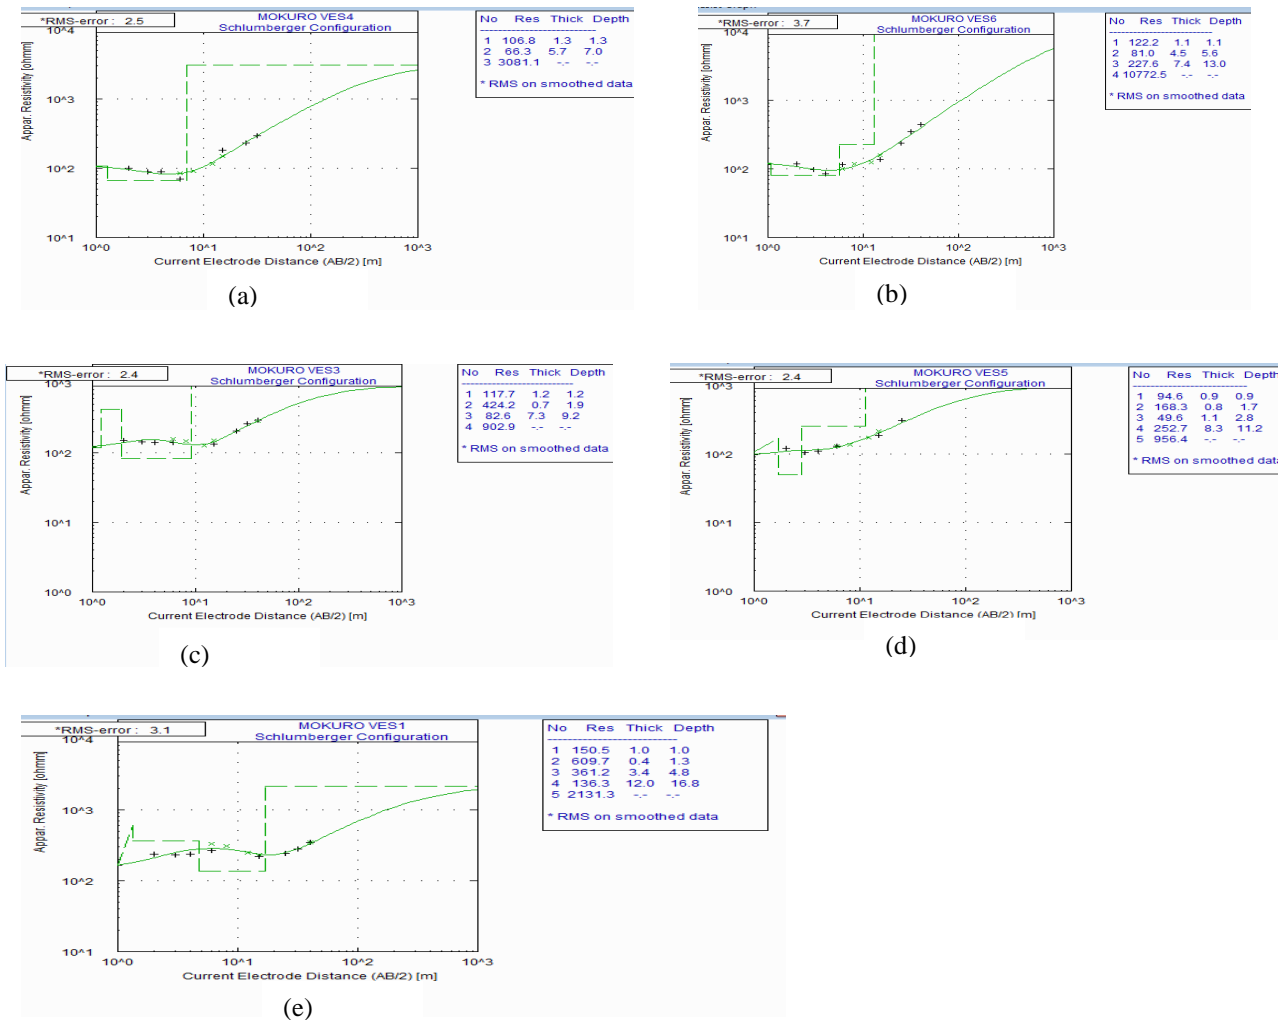
Figure 6: VES Curves (a) H Type, (b) HA Type, (c) KH Type, (d) KHA Type, (e) KQH Type.

by visual inspection and semi-quantitatively for target position and depth to the top of the magnetic source using Parasnis, 1986 method. The SP data were presented as profiles (Figure 5) and were interpreted qualitatively by visual inspection. The observed VES curves (H, HA, KH, KHA and KQH types (Figures 6 a-e)) were interpreted quantitatively by partial curve matching and 1-D forward modeling using WinRESIST 1.0 Software (Vander Velpen, 2004). The final VES interpretation results obtained were used to generate a geoelectric section (Figure 7) beneath the dam embankment. The dipole-dipole data were inverted to 2-D electrical images (Figures 8 a-c) using the DIPRO for Windows Software.

and thicknesses of between 0.7 and 3.8 m. The third layer which represents the embankment core shows resistivity and thickness ranges of 58-142 Ωm and 1.1-16.6 m, respectively. The fourth layer is a partly weathered/fractured basement with resistivities of between 228 and 253 Ωm and thicknesses of between 7.4 and 8.3 m. The last layer is the basal fresh basement bedrock with a resistivity range of 903-10773 Ωm .
