Geophysical Investigation of a Suspected Foundation Failure at Ogbomoso, Southwestern, Nigeria.

A geophysical investigation was carried out around the abandoned Ogbomoso North Local Government Secretariat Complex Building with a view to identifying the cause(s) of the failure of the foundation of the building.

It is suspected that the failure of the building foundation may have been precipitated by differential settlement within the suspected faulted zone.

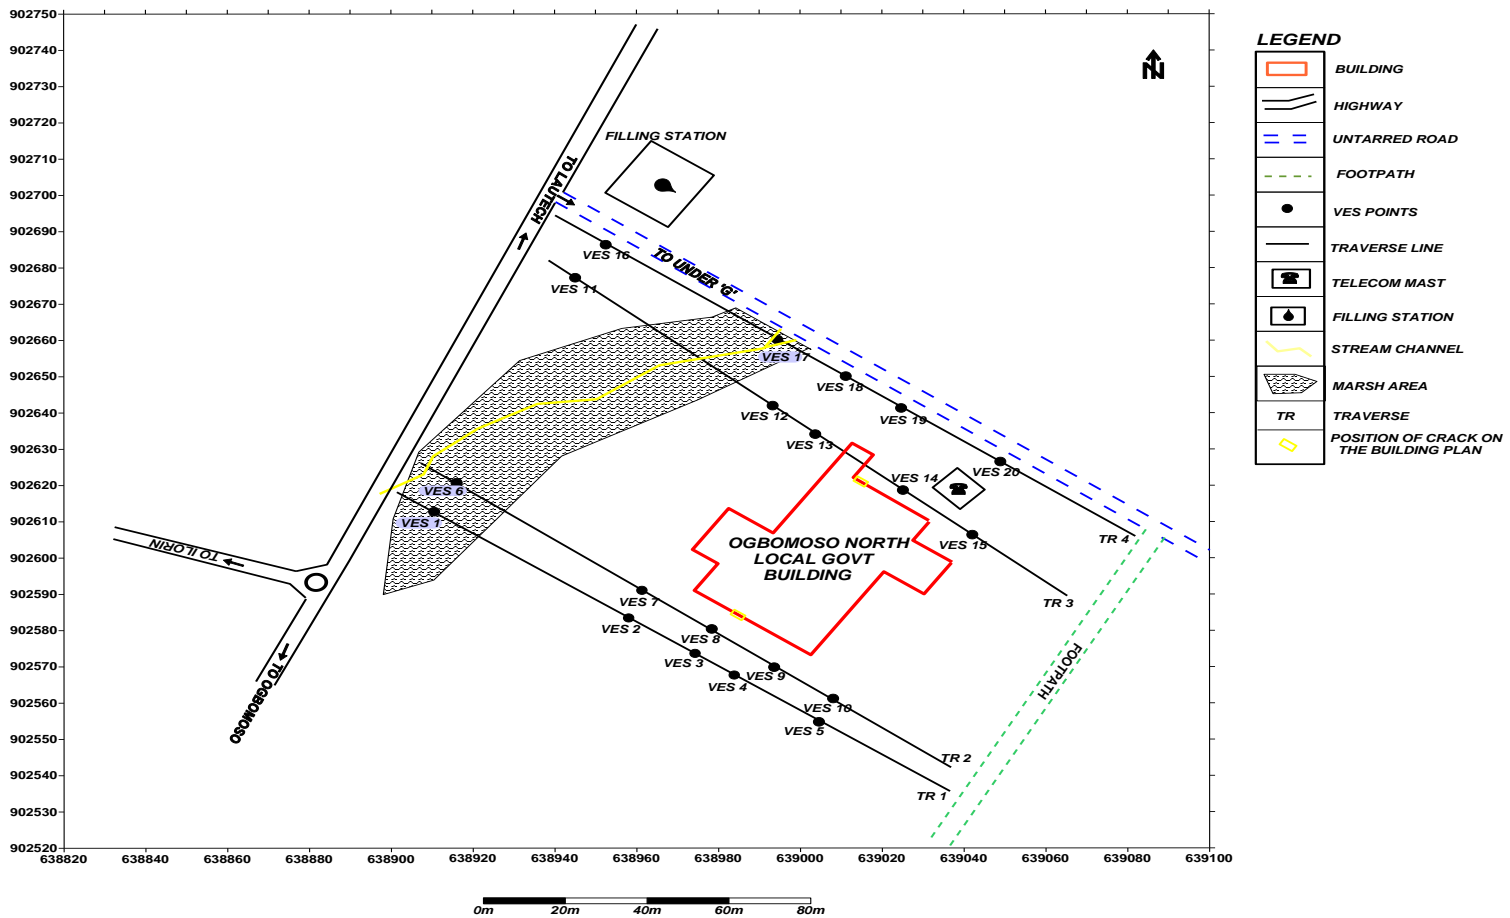
Figure 2: Geophysical Data Acquisition Map

The electrical resistivity method was adopted for the geophysical survey. The survey utilized the Schlumberger Vertical Electrical Sounding (VES) and the dipole-dipole horizontal profiling techniques. The Digital Ohmega Resistivity Meter was used for the data collection. The site layout for the survey is shown in Figure 2. Four (4) traverses were established parallel to the orientation of the building in northwest – southeast direction. Five (5) VES stations were occupied along each of the traverses and located at both side of the building. The Schlumberger electrode spacing was varied from 1 to 65m. For the dipole-dipole profiling, the same four traverses were used for the data collection. The length of the traverses varied from 130 to 135m. The dipole length for the dipole-dipole was 10m, with an expansion factor, n , ranging from 1 to 5. Twenty (20) VES stations were occupied. The GPS was used to record geographical coordinates (in UTM) of the VES stations and the traverse lines.

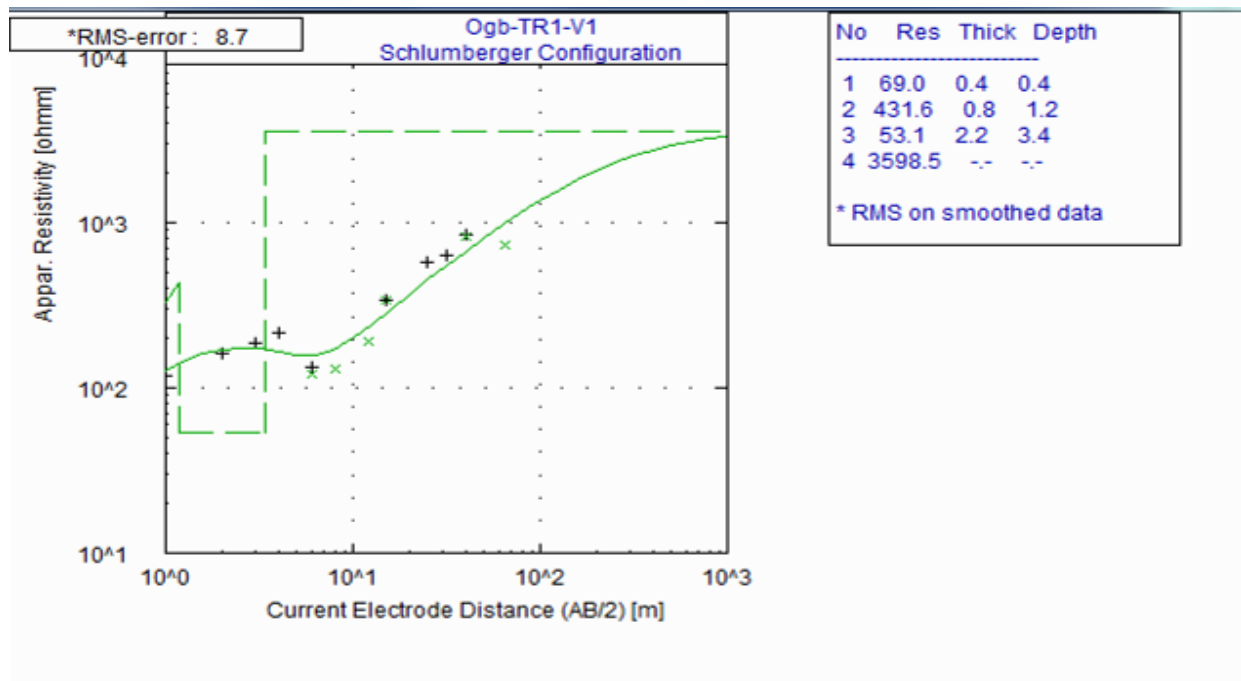
Figure 3a: Vertical Electrical Sounding (VES) KH Type Curve from the Study Area.

The resistivity curves obtained from the survey are the A, H, HA, KH, HKH, and HKHA Type, with the H-Type being dominant (Figure 3). The depth sounding interpretation results (Table 1) are presented as 2-D geoelectric sections (Figure 4). The 2-D subsurface images obtained from the inversion of the dipole – dipole data are presented in Figure 5.
