A Geophysical Investigation of Solid Waste Landfill Using 2-D Resistivity Imaging and Vertical Electrical Sounding Methods in Port Harcourt Municipality, Rivers State, Nigeria.

C.N. Ehirim*, J.O. Ebeniro, and O.P. Olanegan.

Geophysics Research Group, Physics Department, University of Port Harcourt,
PO Box 122, Uniport, Choba, Port Harcourt.

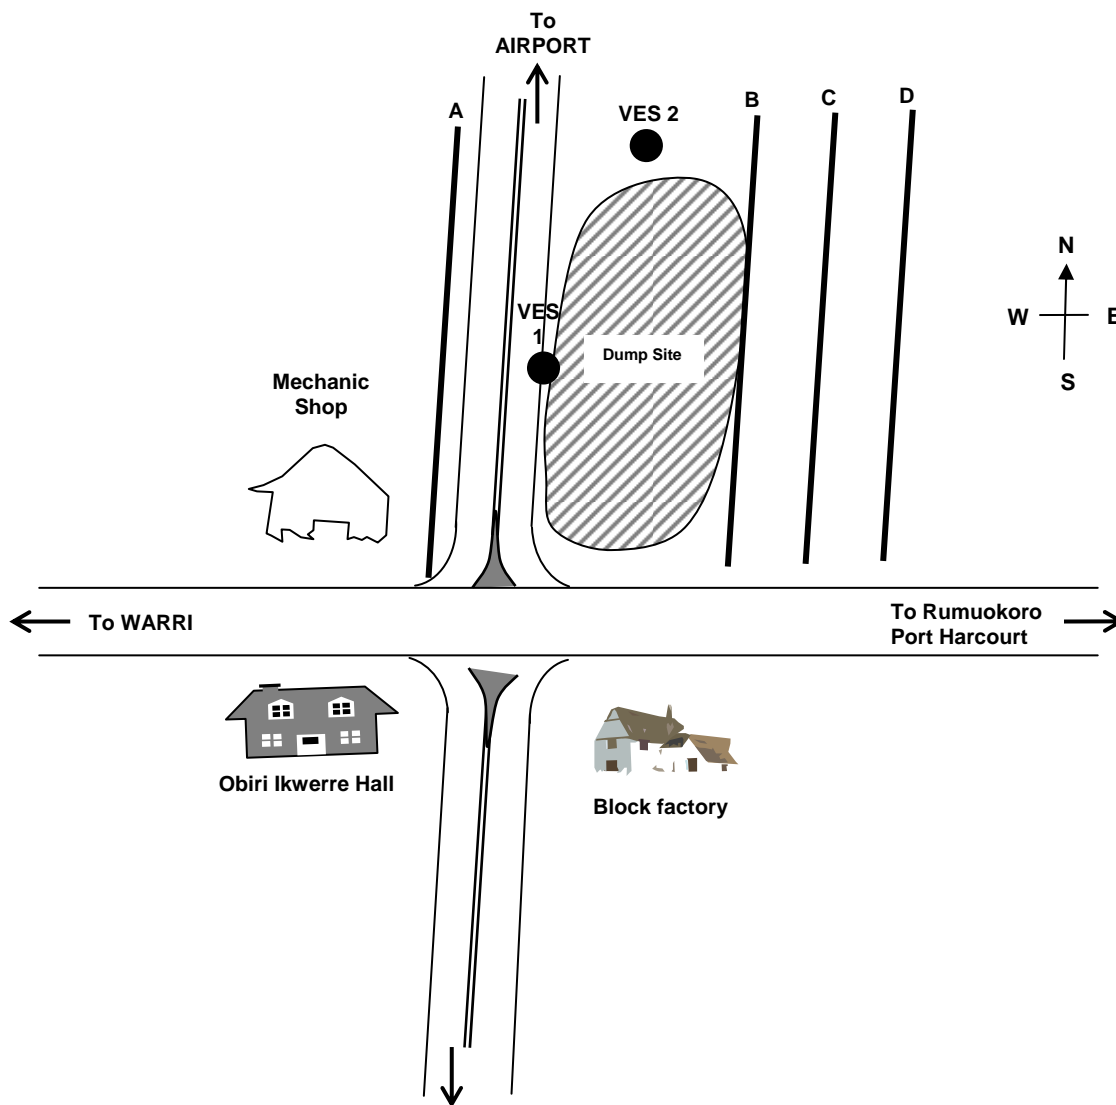
Figure 1: Sketch of the Location of the Dump Site Where the Study was Carried Out.

The landfill site in the present study is located at the Obiri Ikwere-Airport road Junction, along the East-West road, approximately 3km to the east of University of Port Harcourt and covers a total area of about 0.15km². It is delineated between Latitude 4^o52.36'N to 4^o52.75'N and Longitude 6^o57.17'E to 6^o57.43'E (Figure 1).

western edge of the landfill and ran parallel to the profile lines while VES 2 was located on the northern edge of the landfill but ran perpendicular to the profile lines (Figure 1). A maximum AB/2 distance of 350m and MN/2 distance of 30m were occupied. Finally, a record of the variation of the apparent resistivity of the subsurface with depth for each survey was obtained. This investigation was carried out during the dry season by which time the water table was at its deepest level.

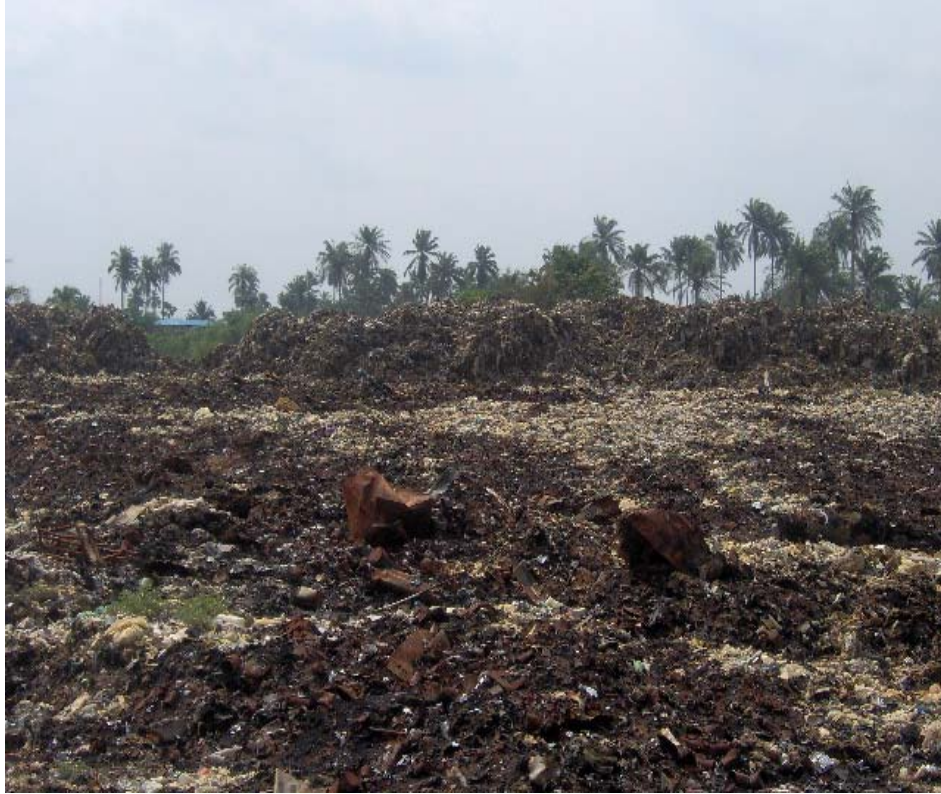
Figure 2a: Dumpsite Showing its Surface Composition Viewed from the East.

The landfill constituents are predominately house hold wastes. Others wastes come from shops, offices, and chemical and manufacturing industries (Figure 2). These wastes may contain toxic substances and as they are decomposed or

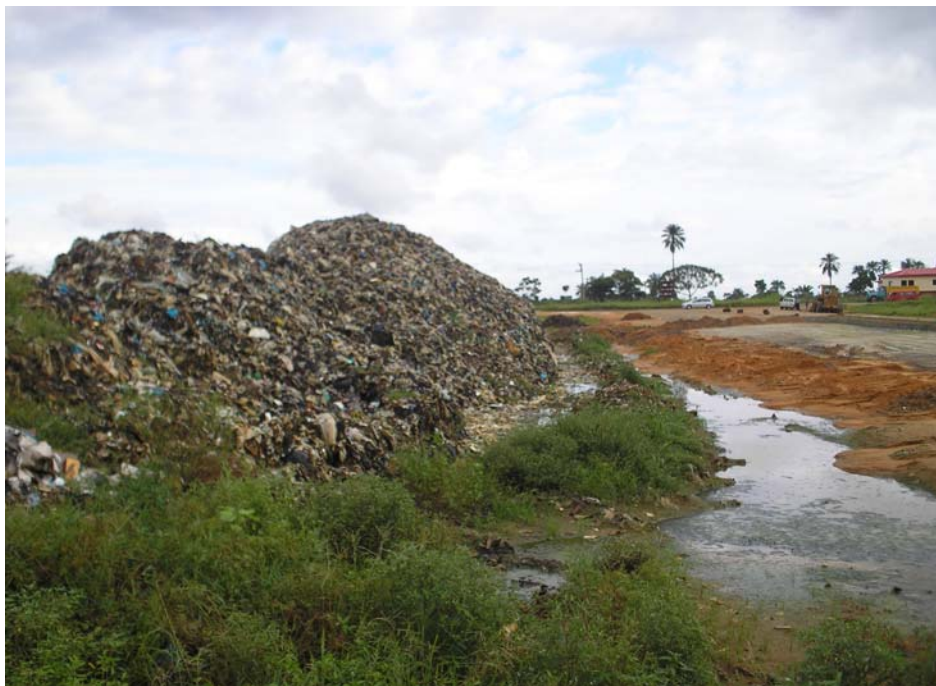
Figure 2b: Concentrated Heap of the Dumpsite Material Viewed Along the New Airport Road from the North.

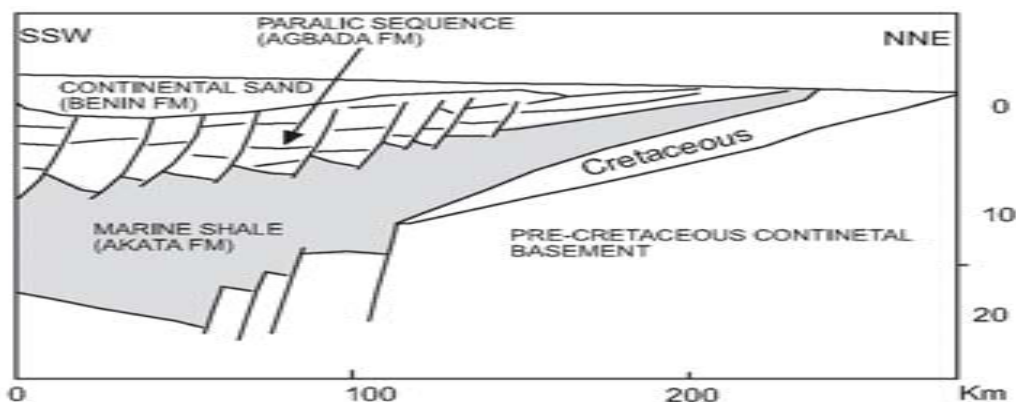
Figure 3: Stratigraphic Section of the Niger Delta Enclosing the Study Area. The Study Penetrated the Benin Formation Sands (Adapted from Awoloye, 2004).

The local geology of the landfill site consists of stratified sediments of the Benin Formation underlain by the paralic Agbada and marine Akata formations, respectively (Figure 3). The Benin formation is a continental deposit of probably upper deltaic depositional environment and the main water bearing formation in the area (Short and Stauble, 1967).

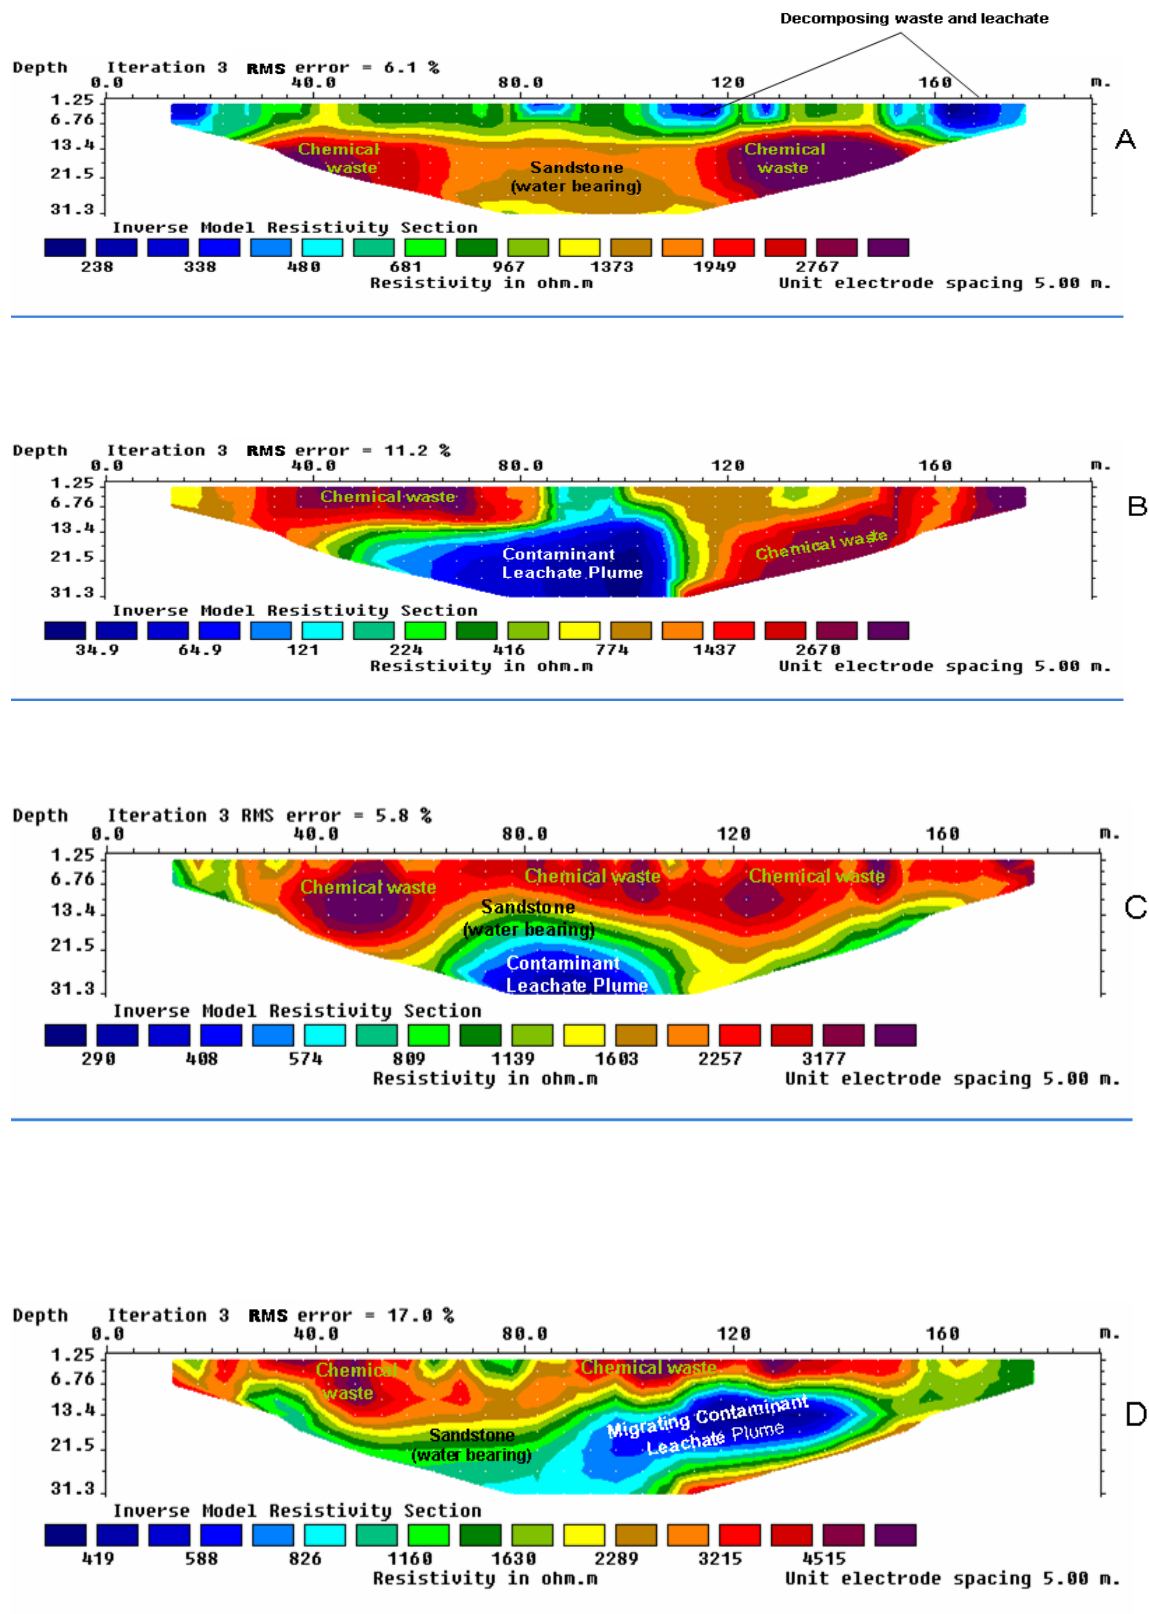
Figure 3: Interpreted 2-D Pseudo Sections of the Profiles (A - D).

The results are displayed as inverted model resistivity sections versus depth of the subsurface along the four profiles (Figure 3). The pseudo sections, consistently show similar structures with variation on the detail level with depth and were visually inspected to delineate areas of anomalously high or low resistivity related to subsurface structures.

Survey Profile 1: This profile is located along the New Airport Road, 20m away from the western edge of the landfill and as such runs in a NE-SW direction (Figure 3A). Low resistivity zones (<338 Ω m) were isolated near the surface with depths of between 1.25m to 8.97m. These are interpreted to be contaminant leachate plume mixed with decomposing waste which indicates the contamination of the surrounding soil. Underlying these low resistivity zone are two isolated zones of high resistivities (>3000 Ω m) to the North and South of the section with depths between 7.81m to 24.76m.

Survey Profile 2: Profile 2 is located at the eastern edge of the landfill and also parallel to profile 1 (Figure 3B). There exist two isolated zones of high resistivity ($>3000 \Omega\text{m}$) to the North and South of the section with depths between 1.25m to 25m. The structure to the south of the section is more pronounced and closer to the surface than the one to the north.

Survey Profile 3: Profile 3 is located 20m away from profile 2, to the east-southeast of the landfill edge (Figure 3C). Isolated circular zones of high resistivity structures ($>3500 \Omega\text{m}$) with depth between 1.25m to 13.4m were delineated along the length of the entire section. The most prominent of these structures occur to the south of the section. These structures are interpreted to be the same high resistive chemical compounds delineated in the two previous profiles. They have been displaced to the topmost part of the entire section, probably by the more dense fluids below.

Survey Profile 4: Profile 4 is located 40m away from profile 2, east-southeast of the landfill edge (Figure 3D). Isolated zones of high resistivity structures ($>5000 \Omega\text{m}$) with depth between 1.25m to 6.76m were delineated. These structures appear to be less prominent in this section compared to the other sections. They are interpreted as the same high resistive chemical compounds delineated in the previous profiles.

The compound was delineated in both the 2-D and VES resistivity sections, respectively, as anomalously high resistivity zones. They are identified and mapped in the inverse model sections as reddish to purple zones of high resistivities between 3000 Ωm to 5000 Ωm and depths between 1.25m to 25m in the entire sections. These pollutants are continuous and displaced to various degrees in each of the inverse models. These suggest that they might be less dense compounds than the groundwater and organic leachate plumes associated with it.

A contaminant leachate plume was delineated in both the 2-D and VES resistivity sections as low resistivity zones. They are identified and mapped as bluish zones of low resistivities between 6.9 Ωm to 419 Ωm and depth between 3.08m to 31.3m in the entire inverse model sections. The least resistivity zone occurred along Profile 2 on the landfill, while the highest occurred in Profile 4. This suggests that the concentration level of the ions in the leachate decreases away from the edge of the landfill as Profile 4 is approached from the west. This is probably due to the filtering action of the various rock layers with distance from the landfill. A potential zone of leachate plume from the landfill was also delineated as a low resistivity zone in the 4th layer of VES 1. This layer has a resistivity of 97 Ωm and depth of 17.3m. This also compares with the range of resistivities and depths of the compounds in the inverse models.
